PROPOSED CHANGE ORDER REQUEST

Contract Name: Design/Build Roof Replacement & Painting of Steel Ground Storage Tanks at Scott Candler Water Treatment Plant **Date:** 6/1/2020
Contractor: Reeves Young LLC
Contract Number: 1073854 **Contract Amendment Number:** 2
Contract Amendment Category: Cost Schedule Scope Deliverables

Field Report for Site Visit April 1, 2020

Project:	Water Tanks Repairs in Scott Candler Water Filtration Plant (SCWFP)	www.woodplc.com
Location:	Water Tank # 1, SCWFP, 4830 Winters Chapel Rd, Doraville, 30360	
Client:	DeKalb County Department of Watershed Management	
Contractor:	Reeves Young	
Date On-Site:	April 1, 2020	
Purpose of Visit:	Inspect condition of Tank # 1 roof framing members	
Report Date:	April 2, 2020	
Representatives On-Site:	J. Michael Garver P.E.	
Report Reviewed By:	Mirsada Ilic, P.E.

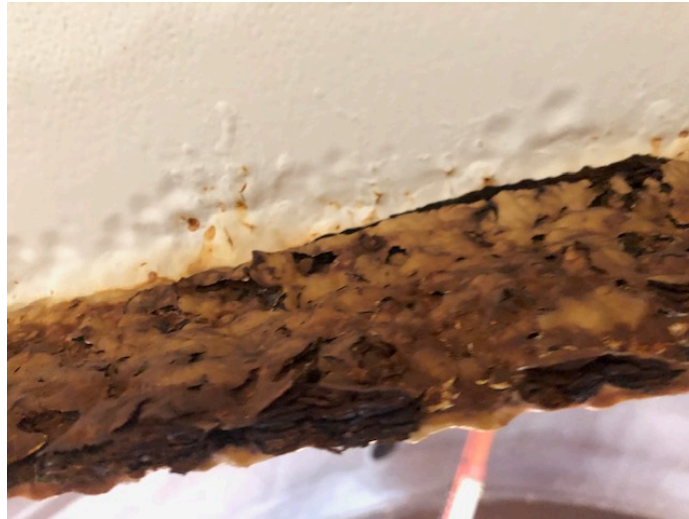
Corrosion and surface condition of beams at roof.

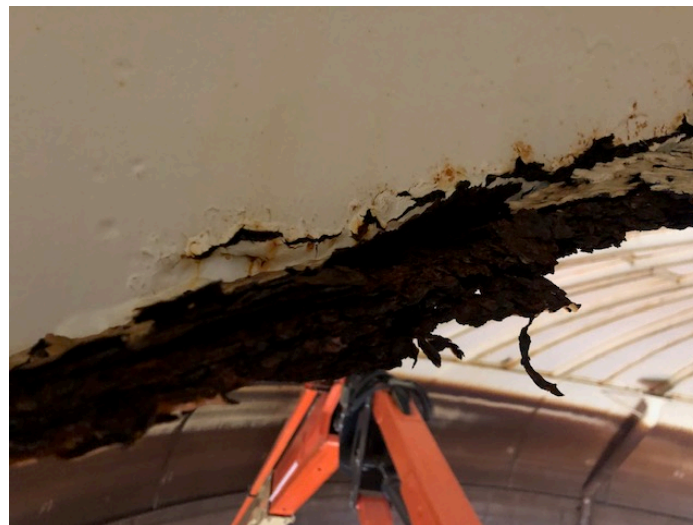
Delamination of beam at roof

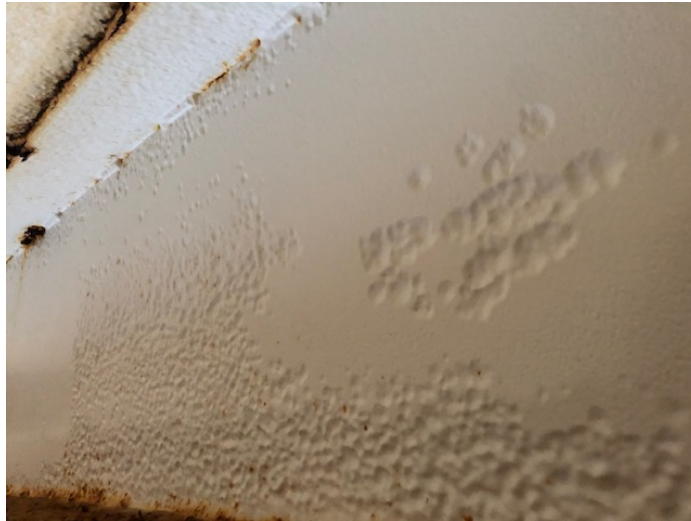
Surface pitting typical throughout tank.

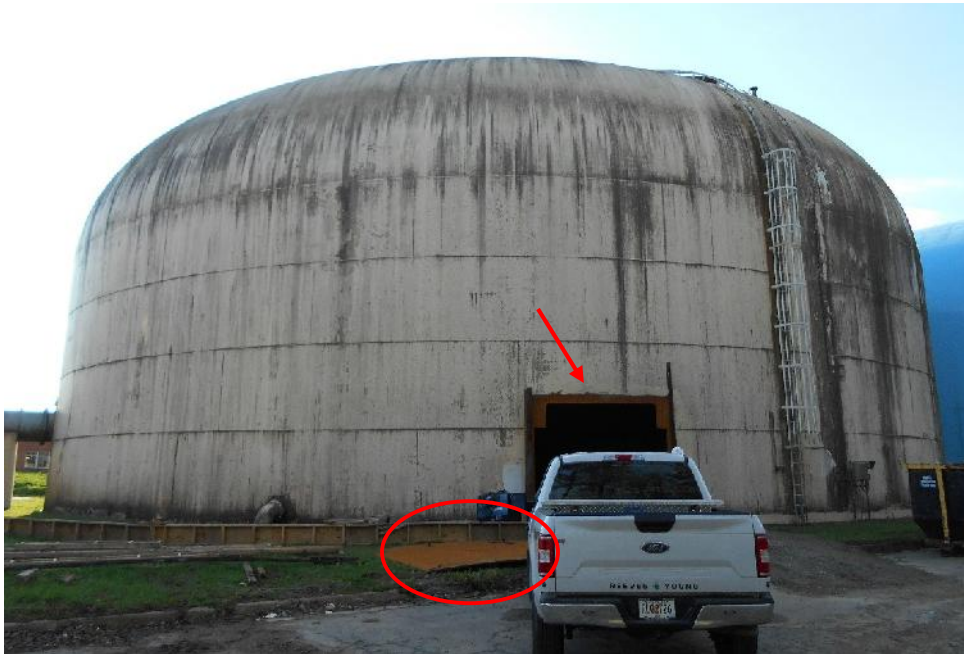
Photograph No. 1:

Exterior view of Tank #1. Arrow indicates sidewall opening and circle indicates removed sidewall section which is approximately 1 1/4" thick and appears to be in good condition.

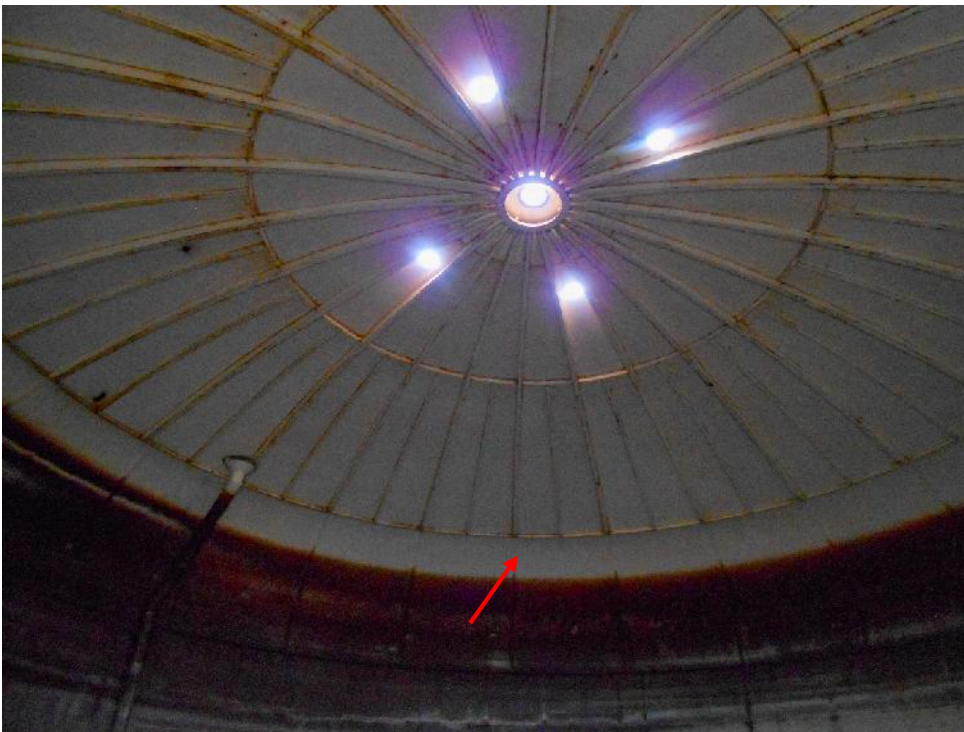
Photograph No. 2:

View from inside Tank #1 from the base of tank. Rusting is evident from the discoloration on the framing members with a white coating. The roof framing system is made from 24 long spanning steel beams with an additional 24 short spanning beams between each long spanning beam. Arrow indicates roof beam support on top of "knuckle" section.

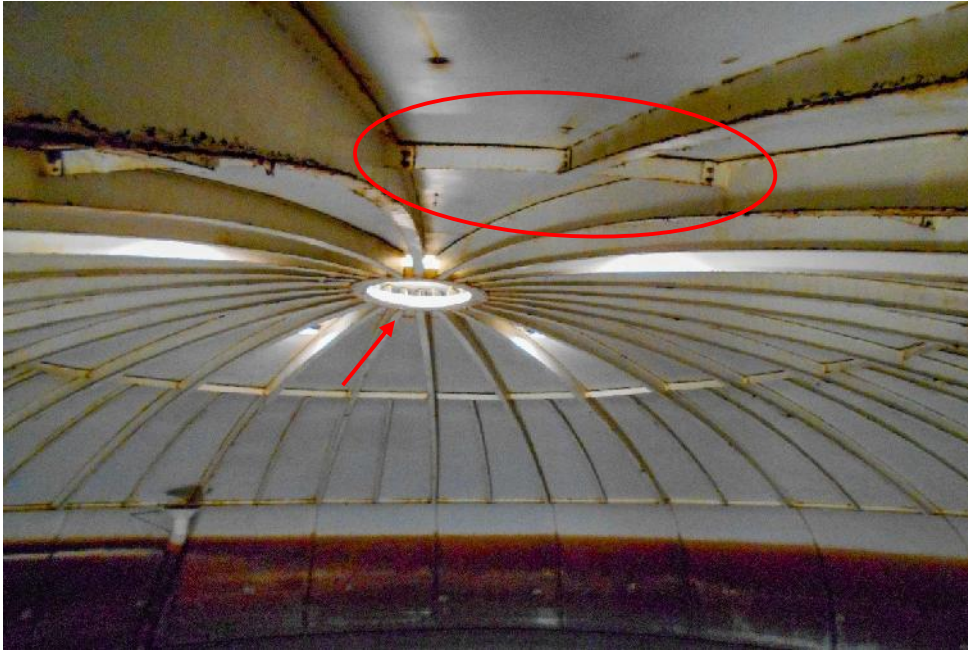
Photograph No. 3:

View of upper roof. Circle indicates transition of short beams to long beams. For more on the transfer beam, see photos 9 through 14. Arrow indicates center steel ring girder. See photos 15 through 17.

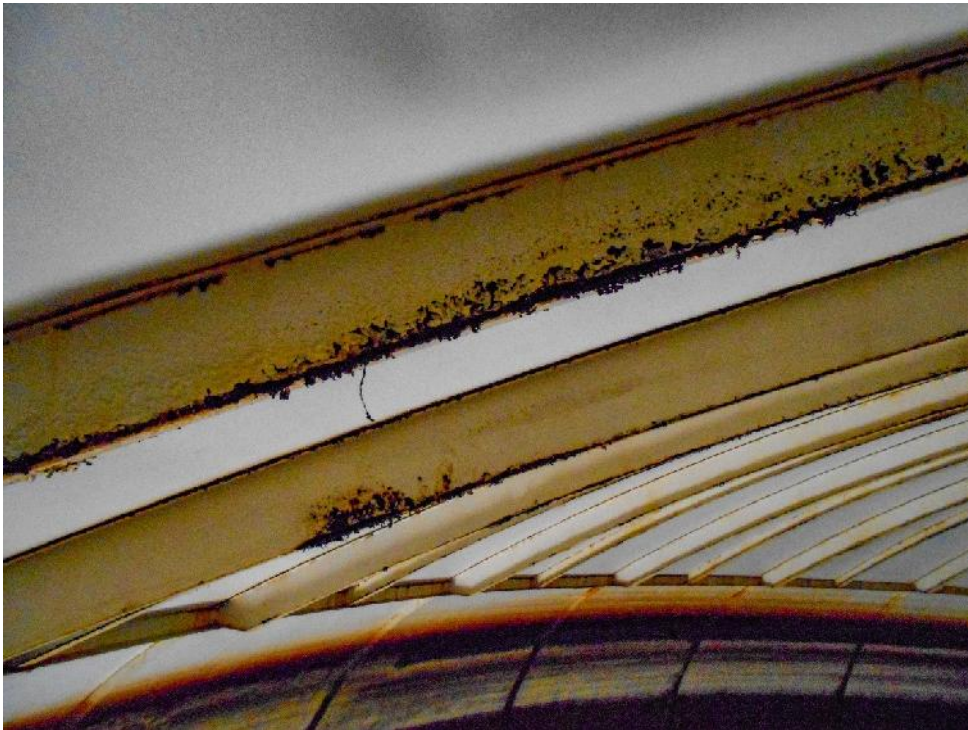
Photograph No. 4:

1. A majority of the long and short roof beams show signs of advanced material loss due to rust. **(Refer to Photographs 4 through 8 and 18)**
2. It appears that the roof beams and underside of the tank steel roof deck have been recoated after previous rust damage. This is evident due to observed pitting in the steel surfaces under the existing coatings. **(Refer to Photographs 5, 6 and 13)**
3. The connections of the 6" x 4" LLV transfer beams were observed to have advanced material loss due to rust including bolts which are extremely compromised beyond a safe load carrying capacity. **(Refer to Photographs 9 through 13)**
4. The long beams bearing on the built-up steel ring girder at the top and center of the tank roof also show signs of advanced material loss due to rust and appear to be compromised from being able to transfer loads. **(Refer to Photographs 15 through 17)**

Typical view of rusting of tank roof beam bottom flange.

It is Wood's recommend the roof structure be replaced.

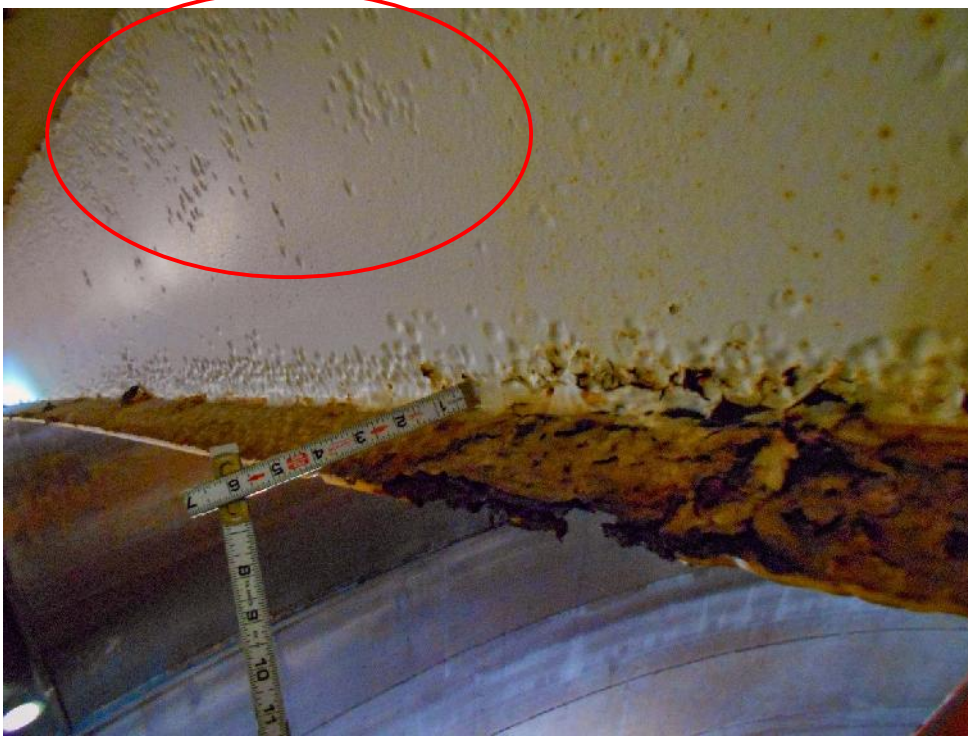
Photograph No. 5:

Representative example of major loss of section on tank roof beam bottom flange. Circle indicates examples of steel pitting prior to previous coating installation.

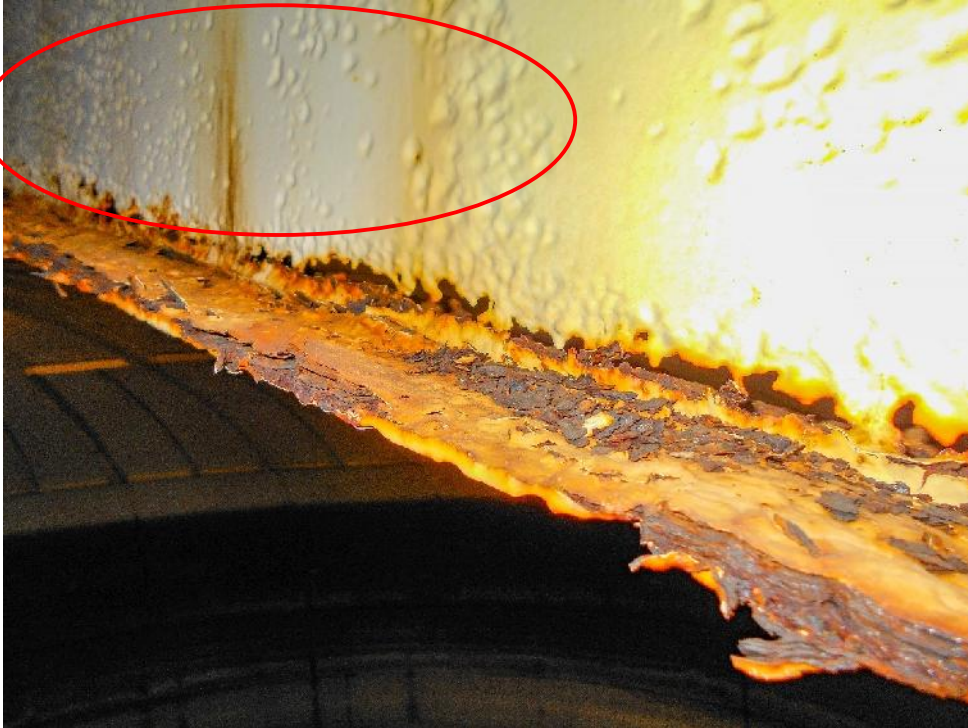
Photograph No. 6:

Representative example of major loss of section on tank roof beam bottom flange. Circle indicates examples of steel pitting prior to previous coating installation.

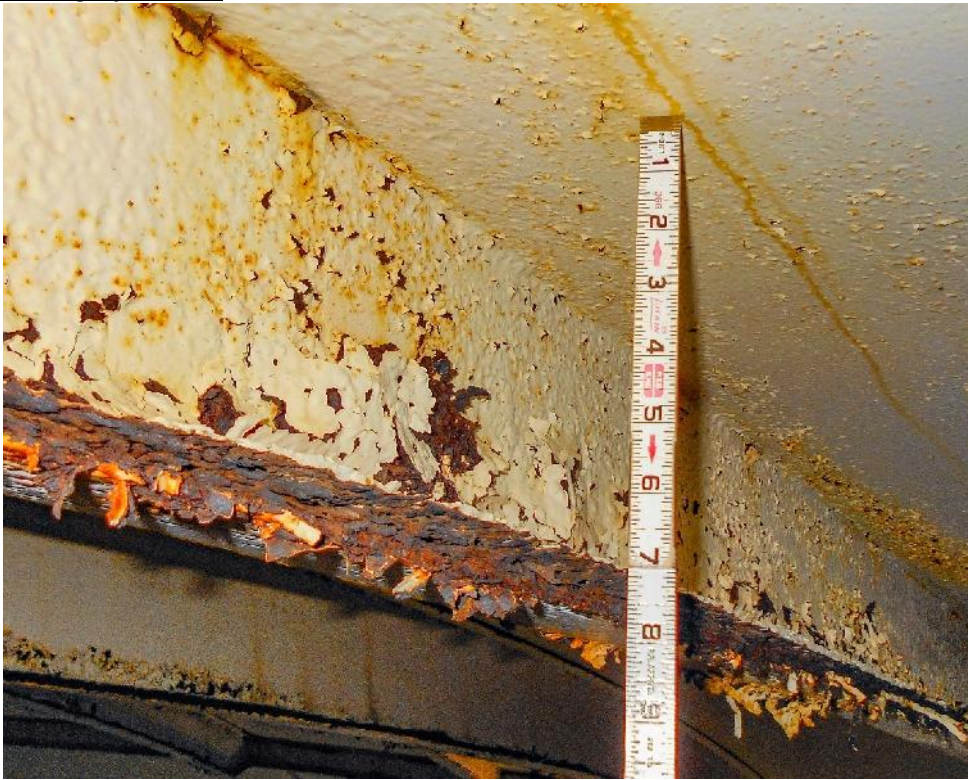
Photograph No. 7:

Representative example of major loss of section on tank roof short beam bottom flange.

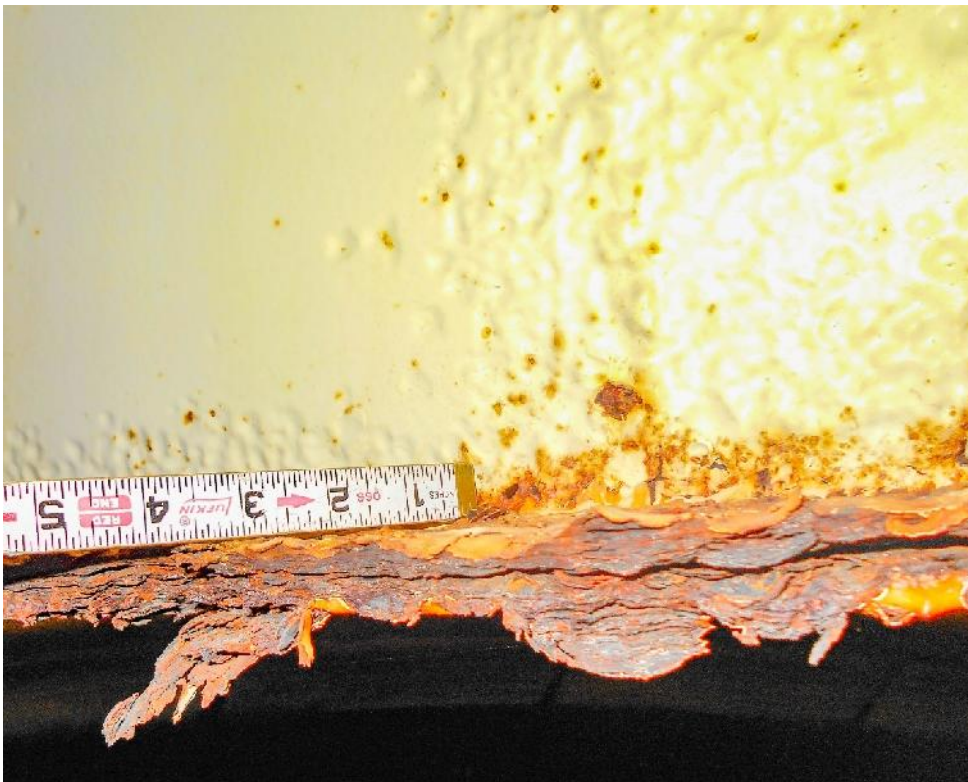
Photograph No. 8:

Close up view of advanced loss of section on tank roof beam bottom flange due to rust.

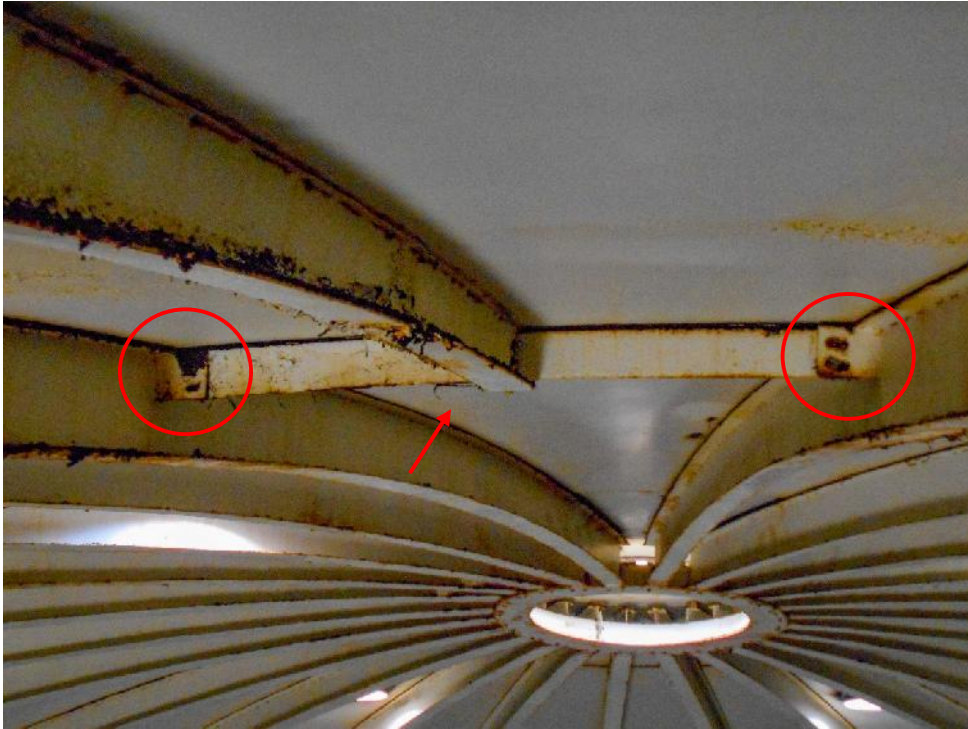
Photograph No. 9:

Outside view of 4" x 6" x 1/4" (LLV) transfer beam. For closer view of connection in left circle, see photo 11. For closer view of connection in right circle, see photo 13 & 14. For closer view of short beam to 4"x6" transfer beam, see photo 12.

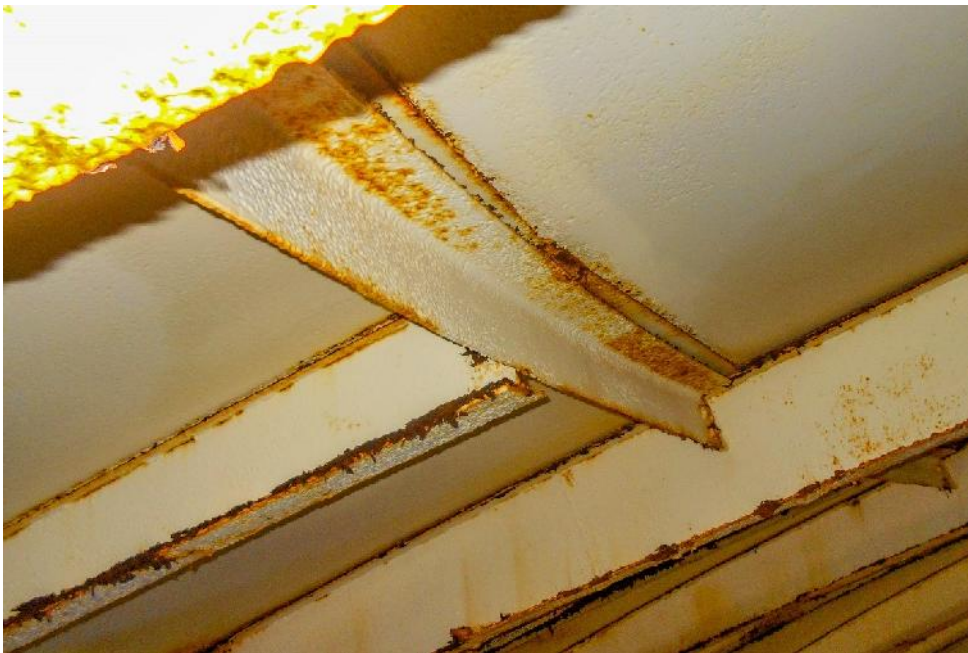
Photograph No. 10:

Inside view of 4" x 6" x 1/4" (LLV) transfer beam.

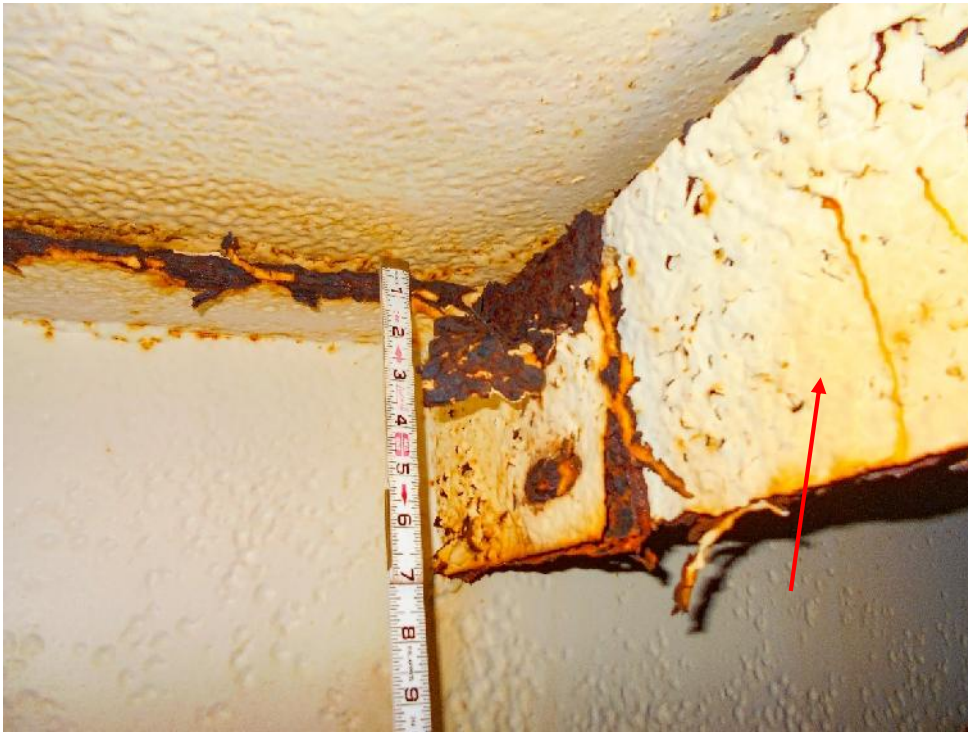
Photograph No. 11:

Advanced rust corrosion of transfer roof beam to long beam. Arrow indicates 6" vertical leg of 6" x 4" transfer beam.

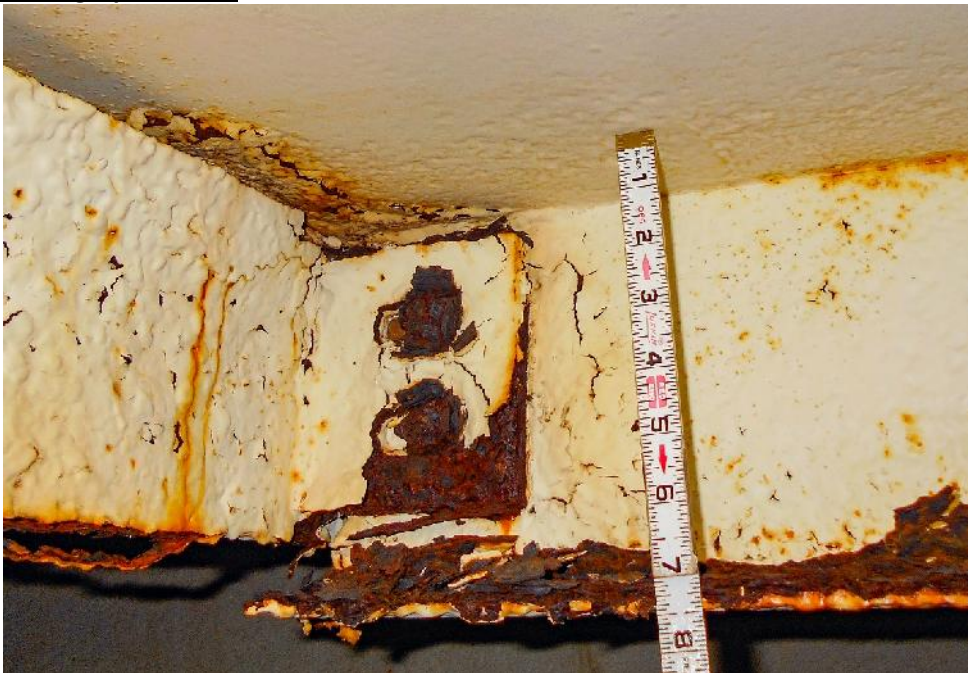
Photograph No. 12:

Advanced rust corrosion of short beam to transfer beam. Ruler is on the side of short beam.

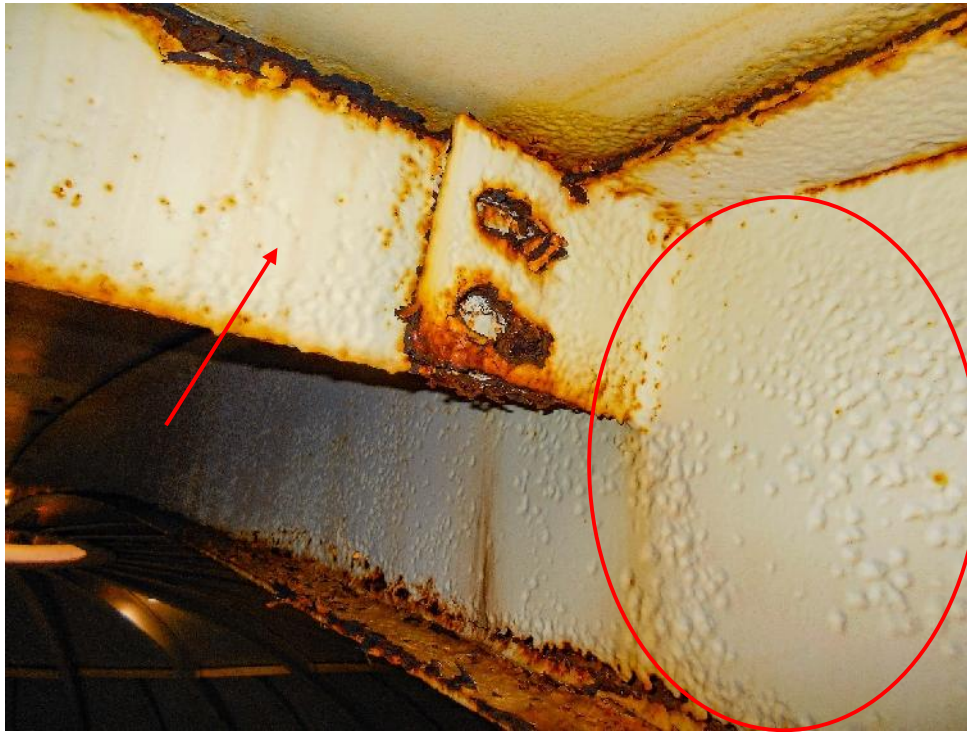
Photograph No. 13:

Outside view of advanced rust corrosion of transfer roof beam to long beam. Arrow indicates 6" vertical leg of 6" x 4" transfer beam. Portion of bolts are missing. Circle indicates examples of steel pitting prior to previous coating installation.

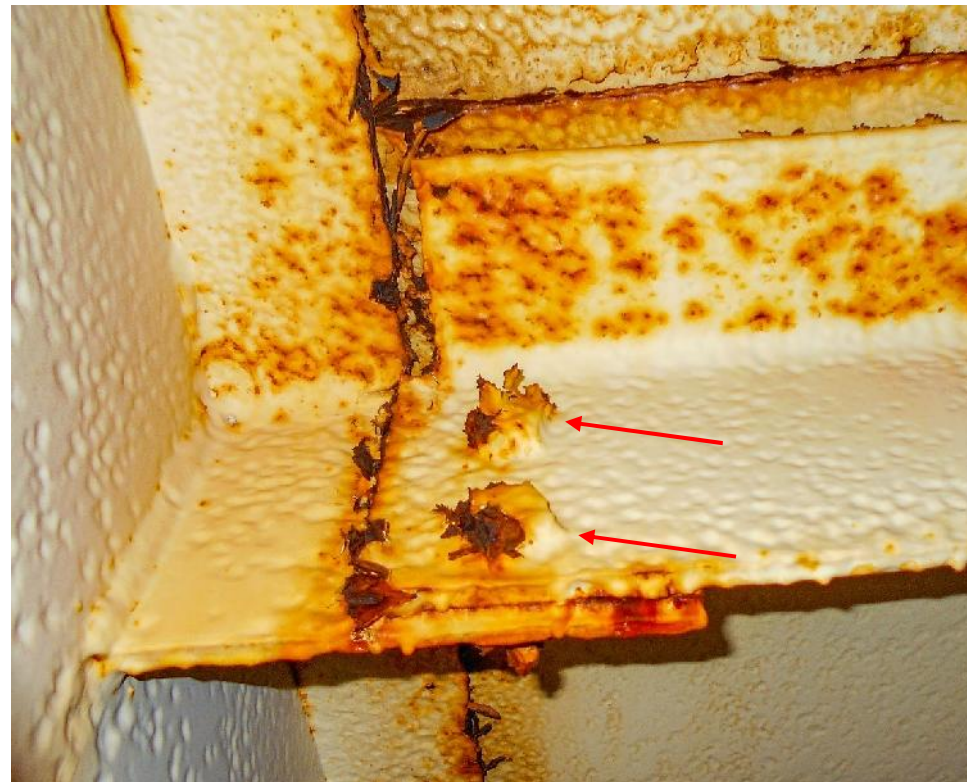
Photograph No. 14:

Inside view of advanced rust corrosion of transfer roof beam to long beam. Arrow indicates remaining heads (or nuts) of missing bolts.

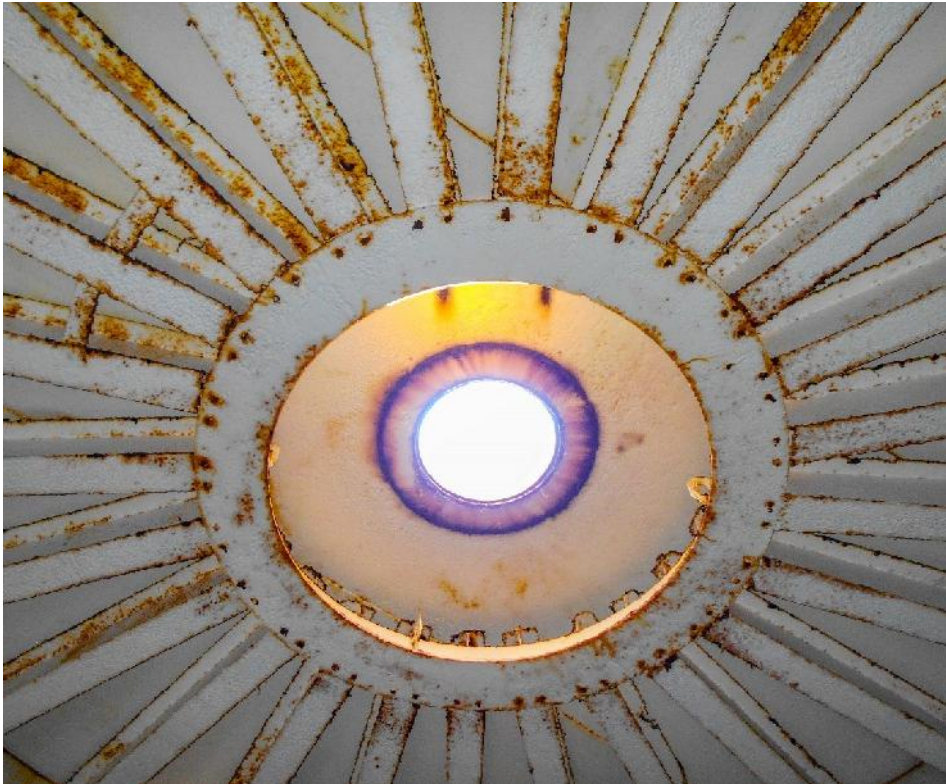
Photograph No. 15:

View looking up at center ring girder.

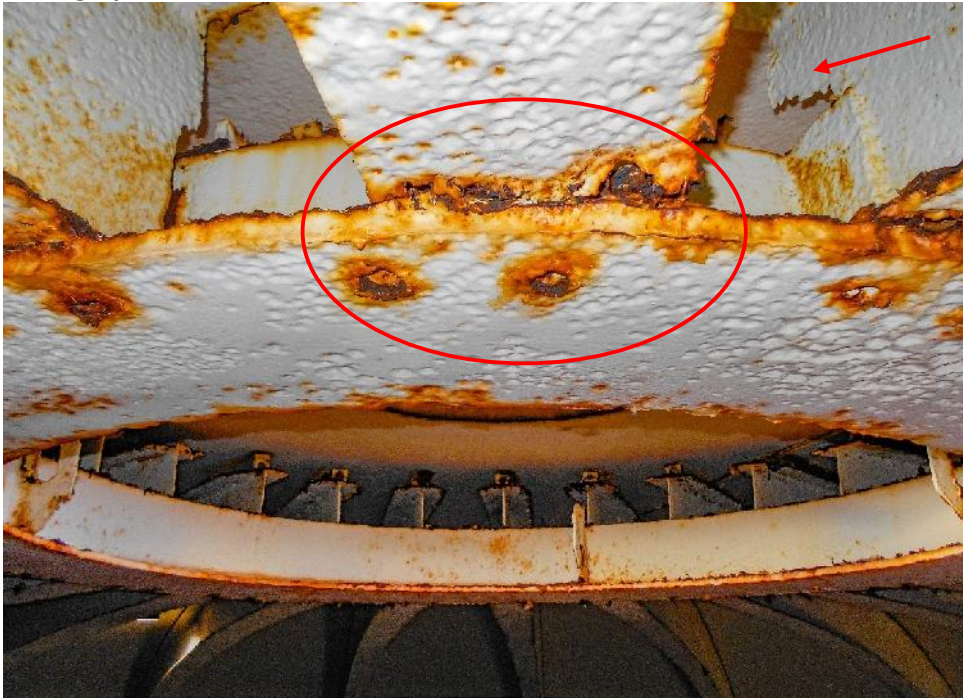
Photograph No. 16:

Close up of roof long beams bearing on ring girder. Circle indicates area of holes in bottom flange due to rust. Arrow indicates example of lost web section in long beam at the bearing due to rust.

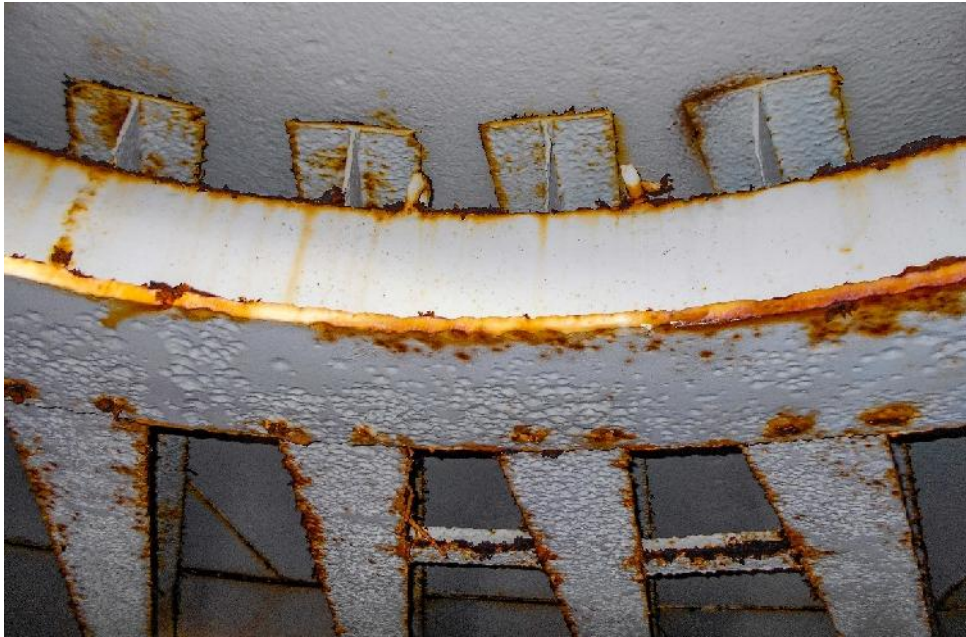
Photograph No. 17:

Inside view of roof long beams bearing on ring girder with advance rusting.

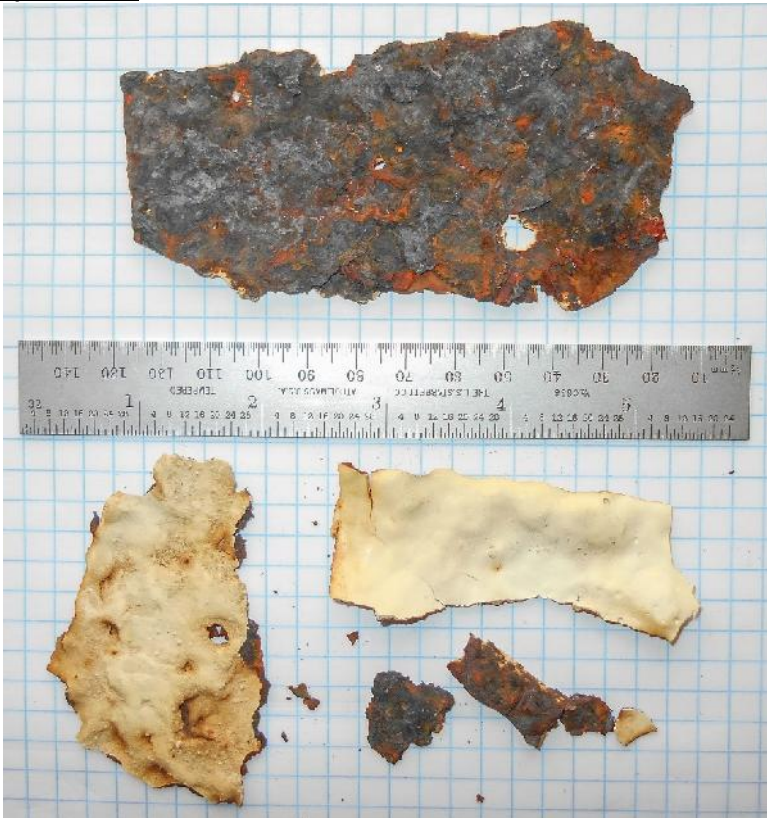
Photograph No. 18:

Sections of beam flange removed by hand. Section above ruler is advanced rusting flange steel with coatings on back side. Larger sections below the ruler are the outside surface of beam flange with coat still adhered.
