SUBJECT: Appeal of Decision of the Historic Preservation Commission
Concerning Property Located at 1853 North Decatur Road by Darrell &
Naomi Johnson Singleterry

Address of Property: 1853 North Decatur Road

SUBJECT PROPERTY-1853 NORTH DECATUR ROAD

SINGLETERRY RESIDENCE

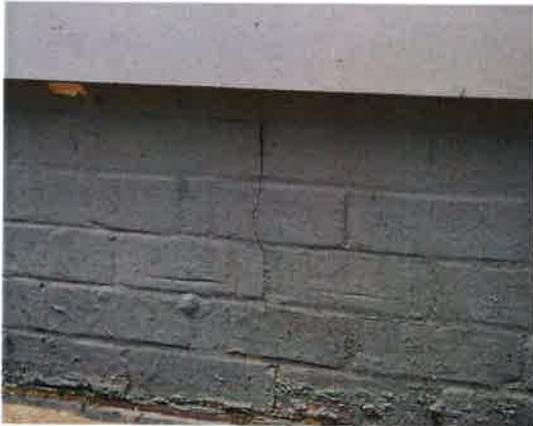
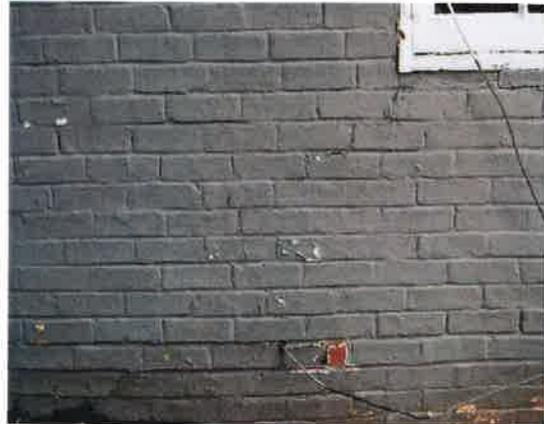
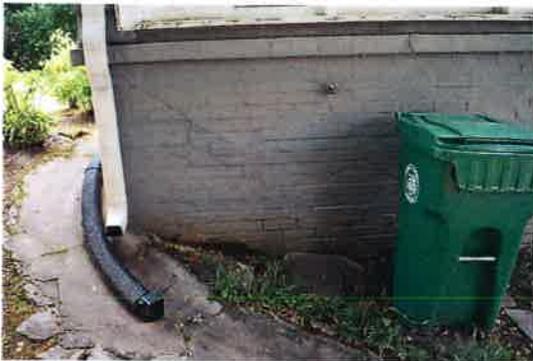
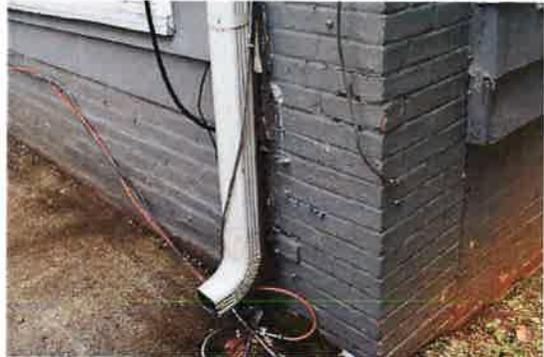
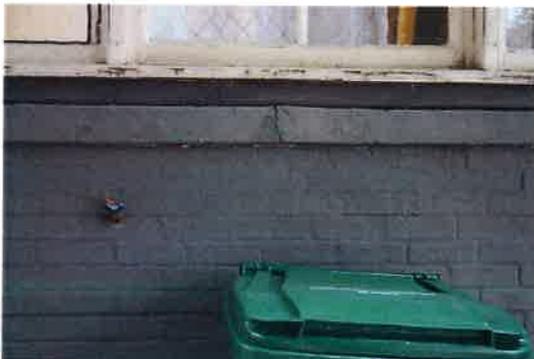
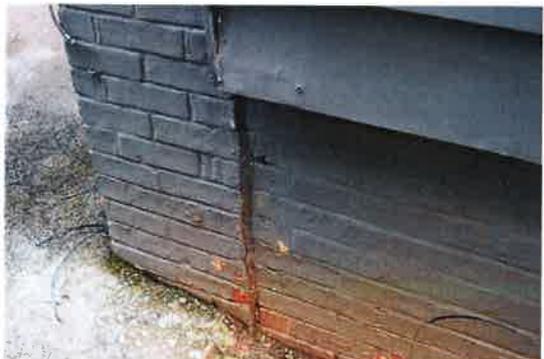
Existing brick cavity stem walls throughout show multiple attempts to point, patch and stabilize settling damage. Attempts as late as 3 years ago are already showing signs of failure.

Extensive cracking in the poured concrete floor of the crawlspace show further settling and soil instability below due to the 15%+ grade and long-term drainage issues.

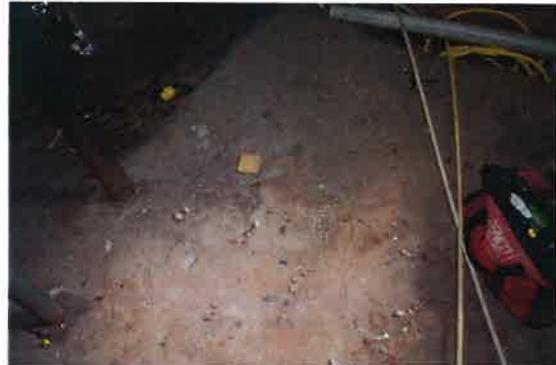
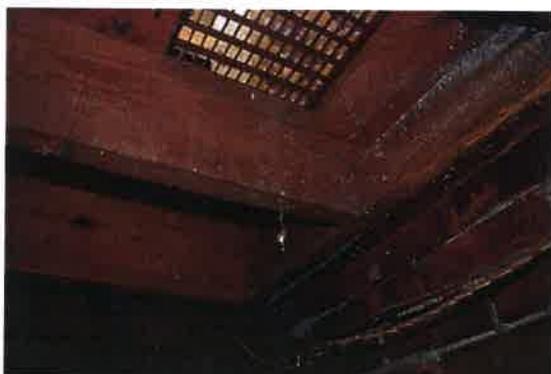
2x8 Floor joists are over spanned 36" average. Sagging entry level floors have been supported via multiple screw jacks in the Crawl/basement. However, 2nd floor joists would require removal of all ceilings, electrical and plumbing to facilitate 'sistering' of all joists.

In an effort to preserve and reinforce the existing structure, the owners had multiple screw jacks installed in addition to CMU walls to counteract the failure of the existing foundation system.

The photo to the right indicates persistent water intrusion under the original cavity stem walls and thru. the new CMU retaining wall

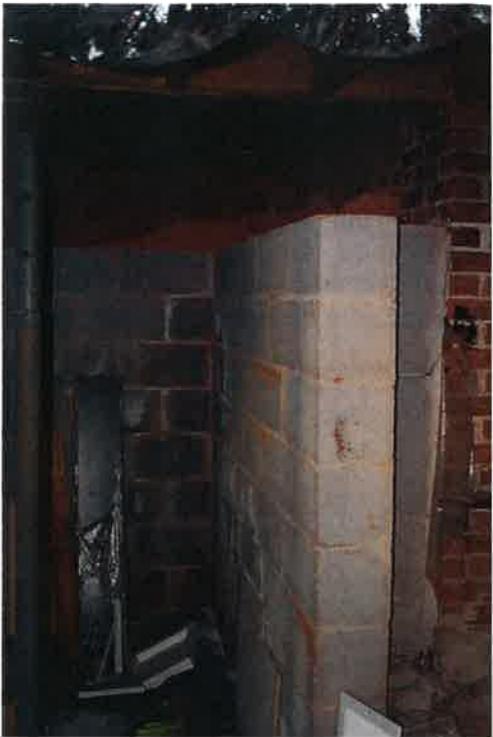
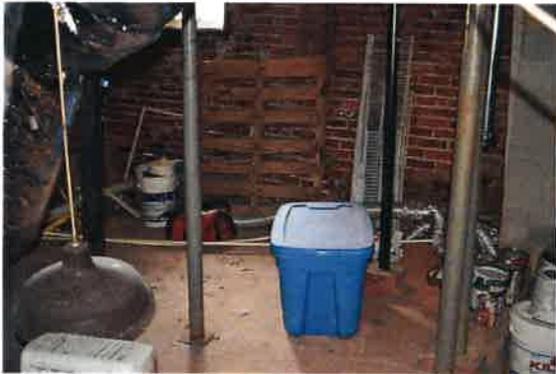
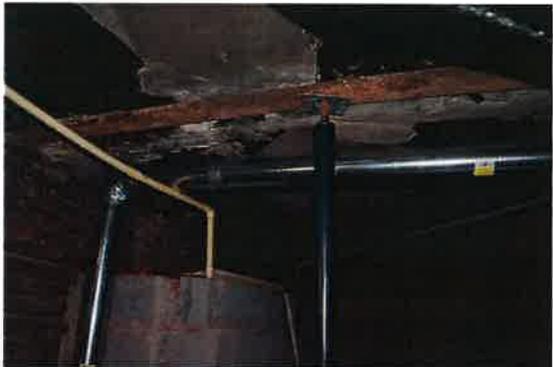
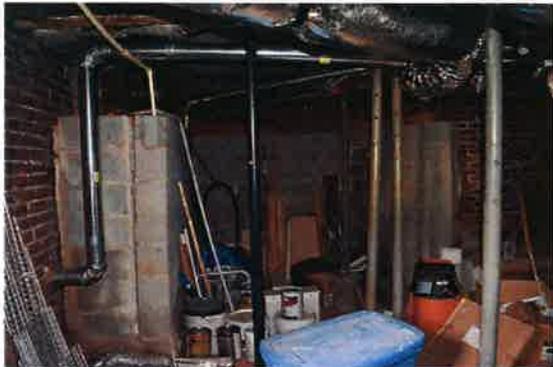
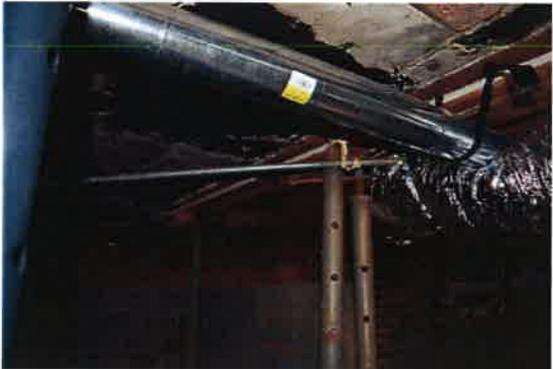
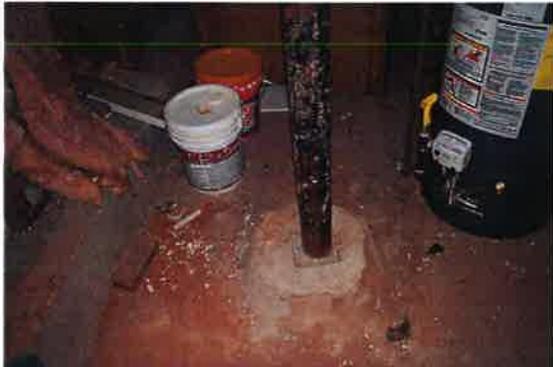
Retrofit steel bracing is supporting over-spanned floor joists, inadequate beams, and a suspended concrete slab. This level is rendered effectively unusable although the bracing employed is still insufficient.

The CMU wall installed three years ago is already showing signs of failure (leaning) and continued water intrusion.

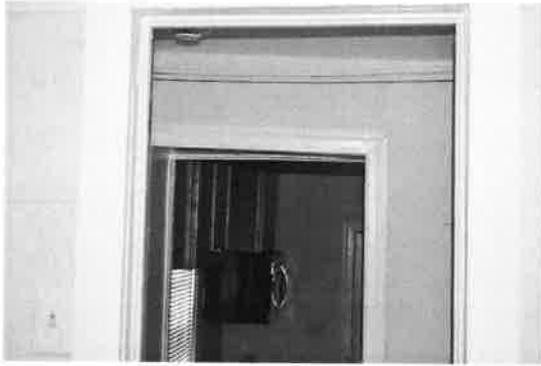
The pillars are showing cracking and signs of settling and unsupported movement.

Terrace level Ceilings are showing deflection from the over spanned floor joists above

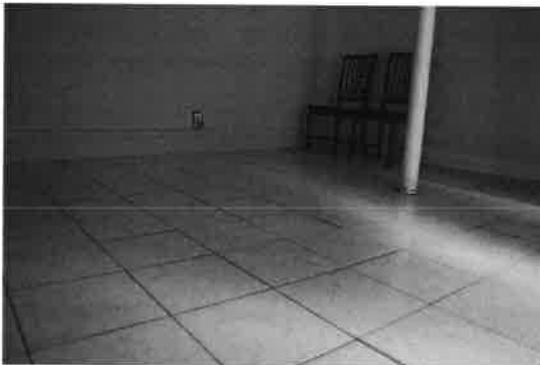
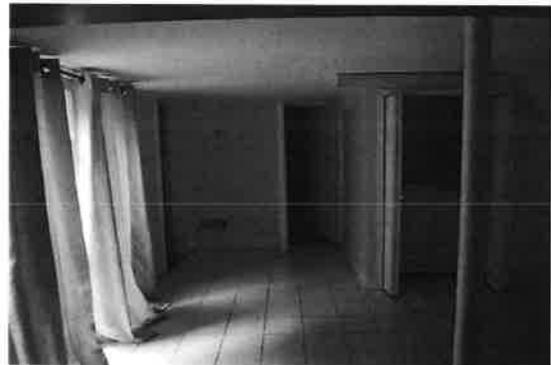
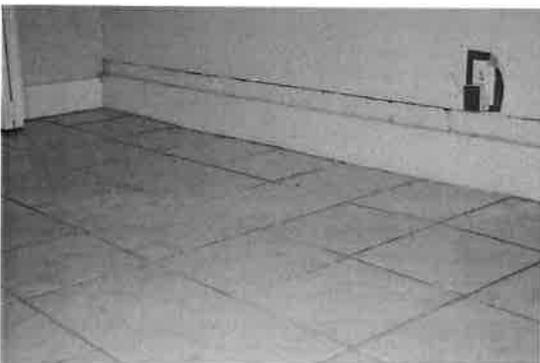
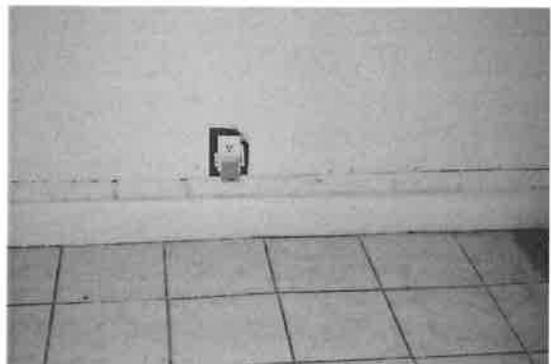
Within the scope of supporting the structure, the homeowners also performed cosmetic repairs throughout the interior of the home. Within 3 years the entry level walls show cracking in the drywall/plaster in numerous areas of the ceiling and wall surfaces, illustrating further movement of the structure post-repair.

In addition to cracking of drywall/plaster, extensive damage can be seen in the tile flooring of the kitchen, and separation within the hardwood flooring due to structure movement .

Uneven floor joists can be seen and felt throughout the entry level.

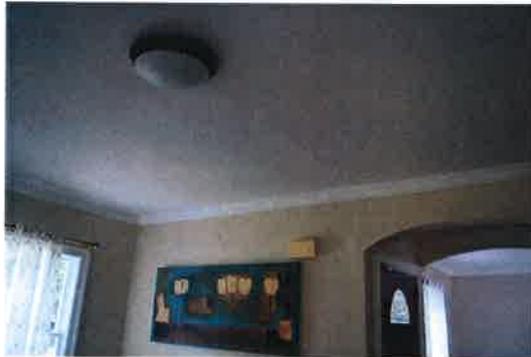
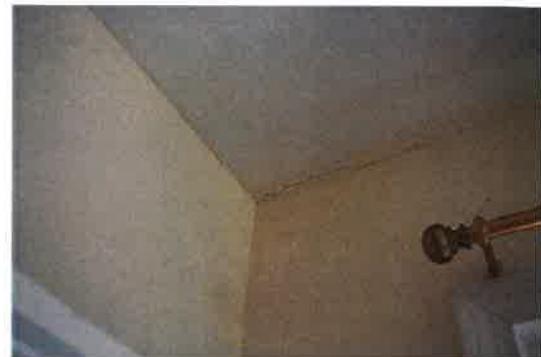
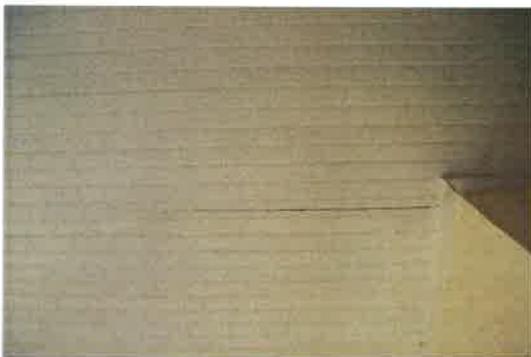
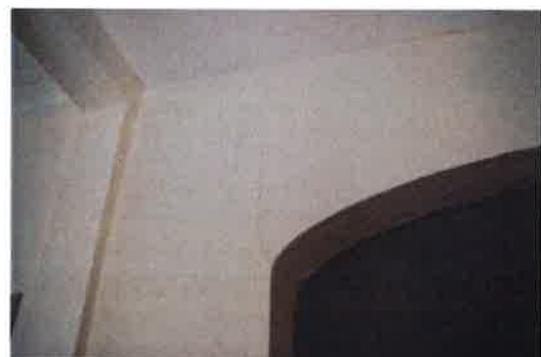
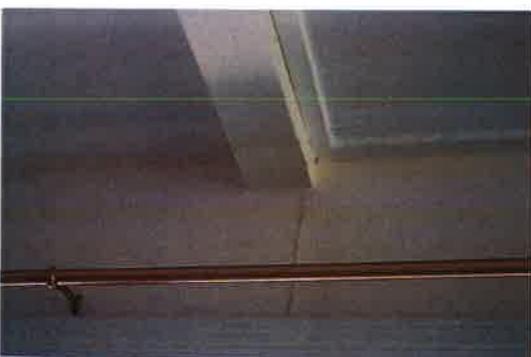
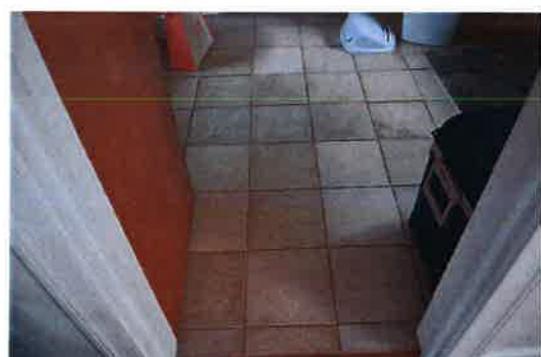
Walls on the upper-level present cracks over doorways, windows, and throughout walls in every room. Baseboard trim illustrates the movement of the floor joists below via gapping. Bathroom floor tiles have separated, unable to withstand the fluctuation of the over spanned floor joists below. Patching measures can be seen throughout that have already separated significantly in 3 years alone.

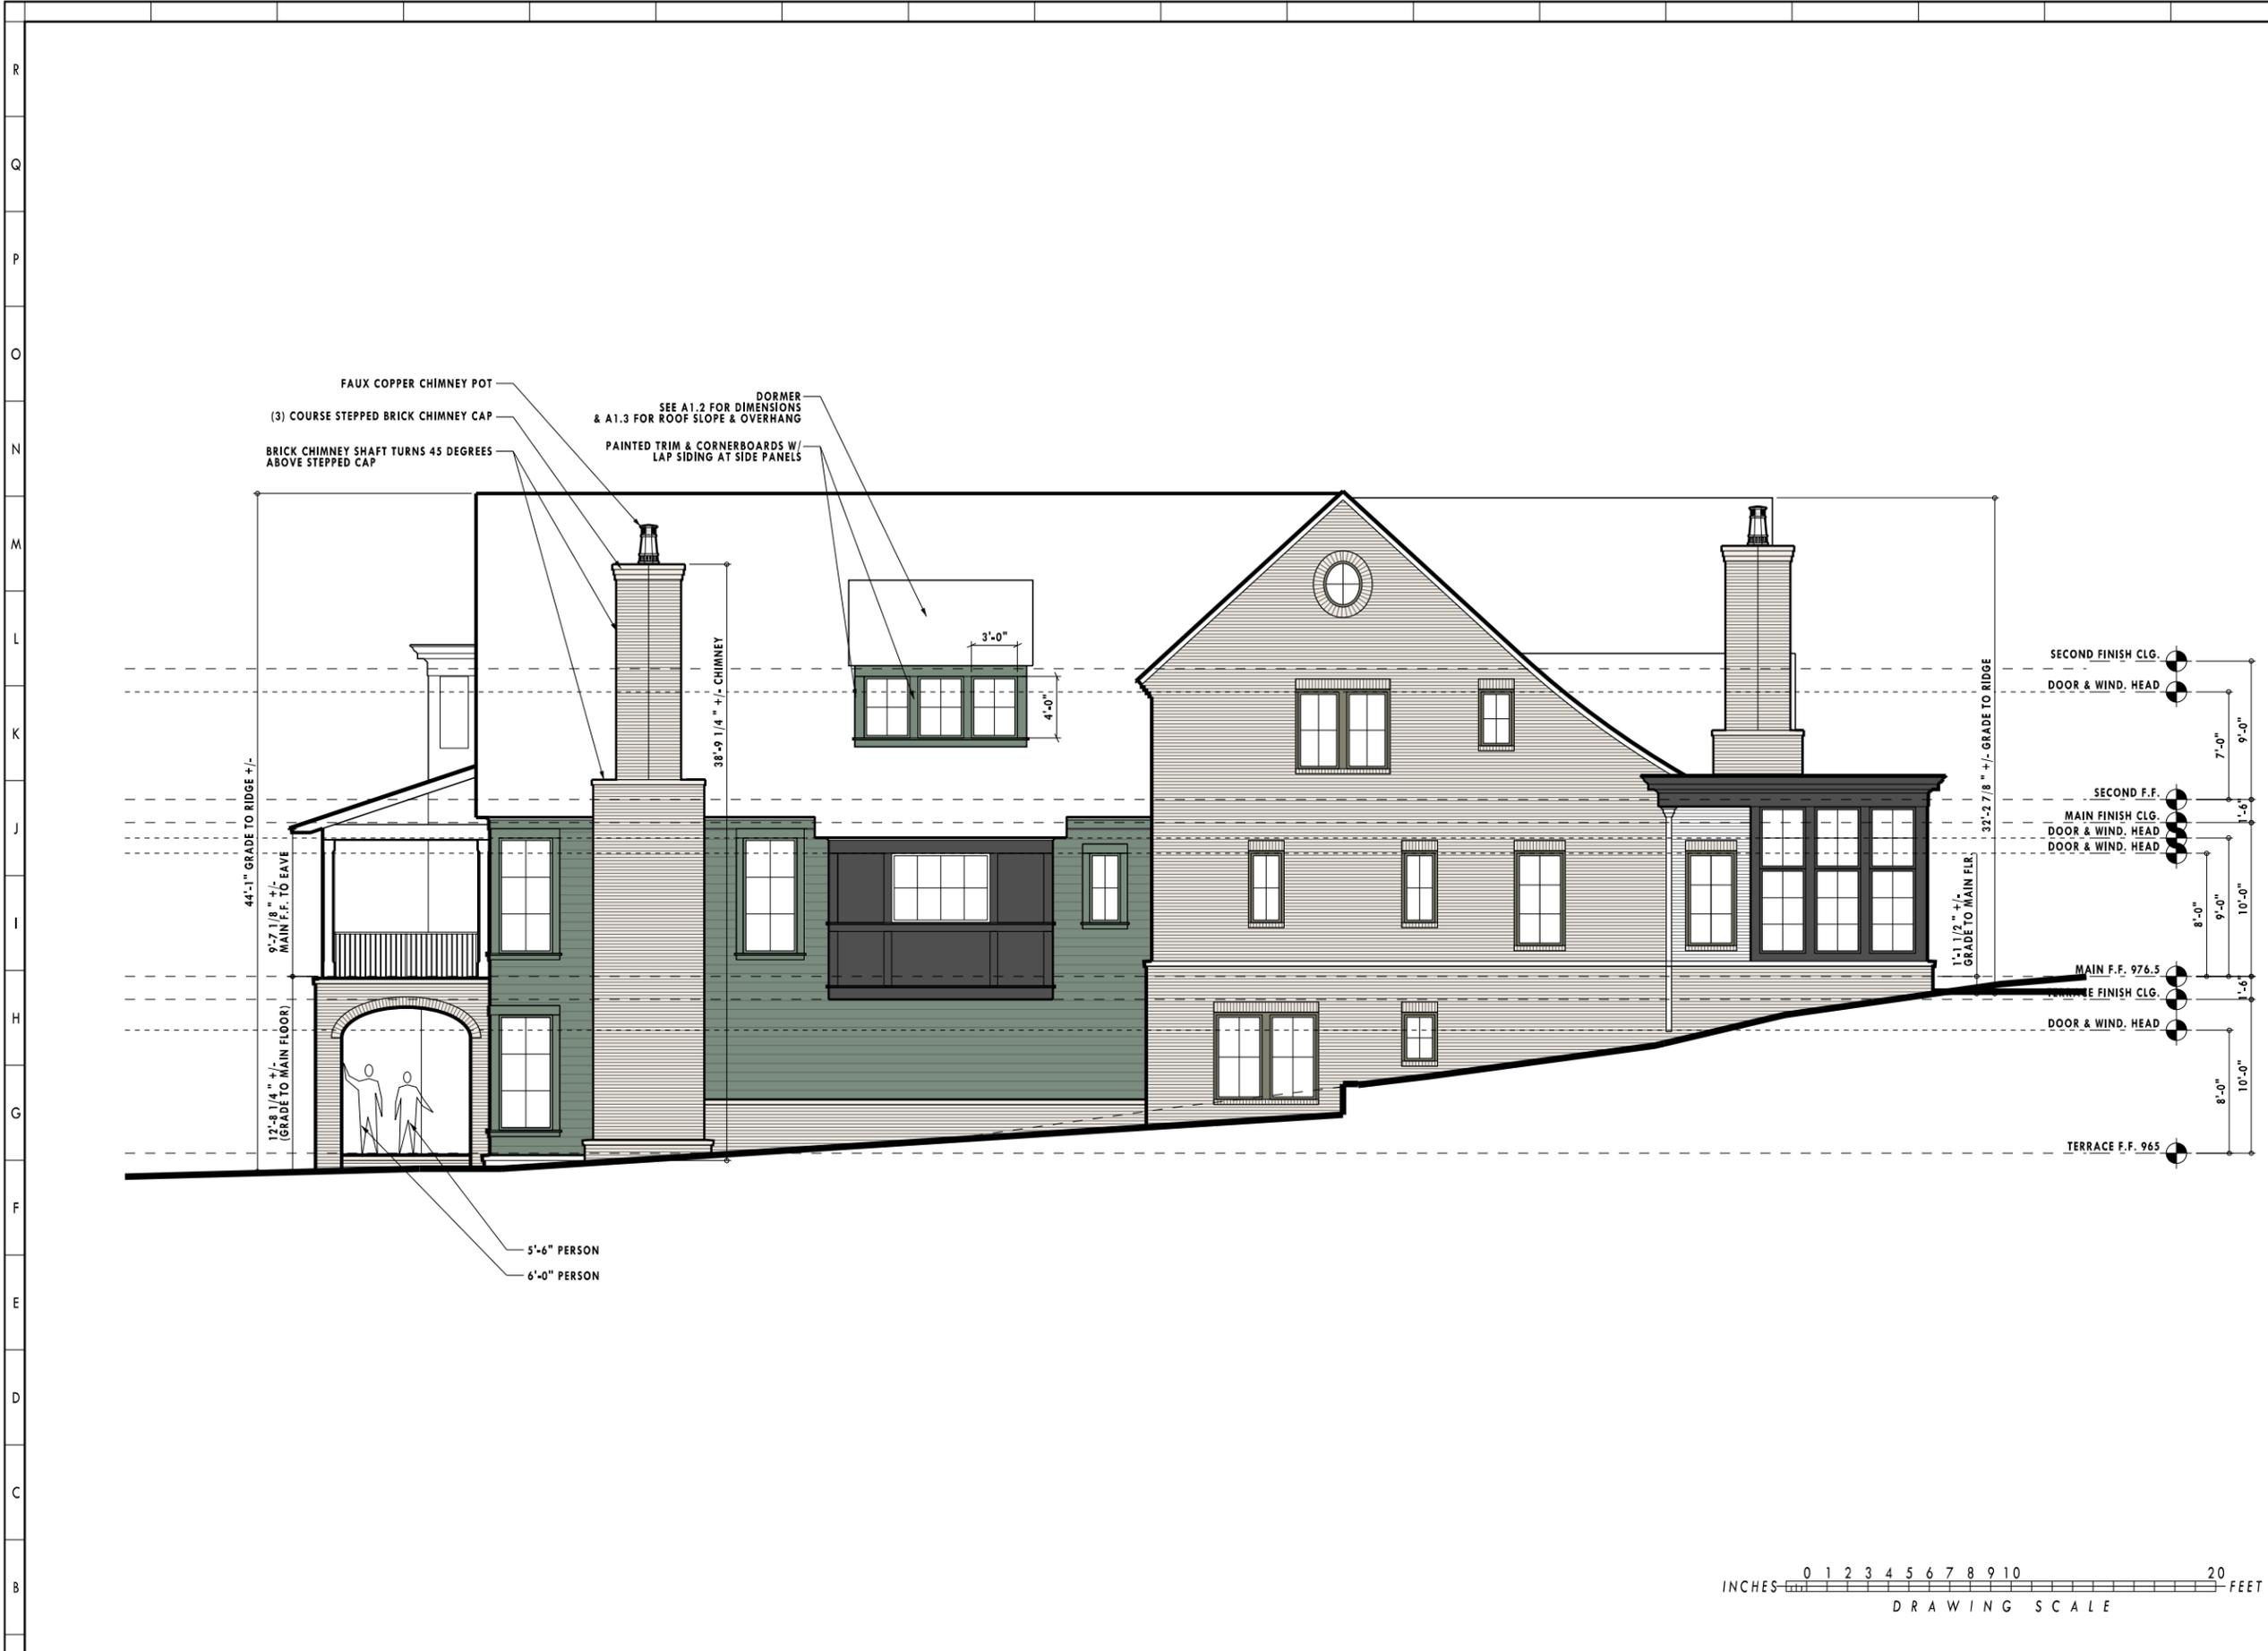
A,1 EXTERIOR ELEVATIONS - REAR (SOUTH)

FAUX COPPER CHIMNEY POT
 (3) COURSE STEPPED BRICK CHIMNEY CAP
 BRICK CHIMNEY SHAFT TURNS 45 DEGREES ABOVE STEPPED CAP
 DORMER
 SEE A1.2 FOR DIMENSIONS & A1.3 FOR ROOF SLOPE & OVERHANG
 PAINTED TRIM & CORNERBOARDS W/ LAP SIDING AT SIDE PANELS

SECOND FINISH CLG.
 DOOR & WIND. HEAD
 7'-0"
 9'-0"
 SECOND F.F.
 MAIN FINISH CLG.
 DOOR & WIND. HEAD
 DOOR & WIND. HEAD
 1'-6"
 9'-0"
 10'-0"
 MAIN F.F. 926.5
 FINISH CLG.
 DOOR & WIND. HEAD
 1'-6"
 8'-0"
 10'-0"
 TERRACE F.F. 965
