SUBJECT: Appeal of Decision of the Historic Preservation Commission
Concerning Property Located at 1853 North Decatur Road by Darrell &
Naomi Johnson Singleterry

Application to Appeal a Decision of the DeKalb County Historic Preservation Commission

Address of Property: 1853 North Decatur Road

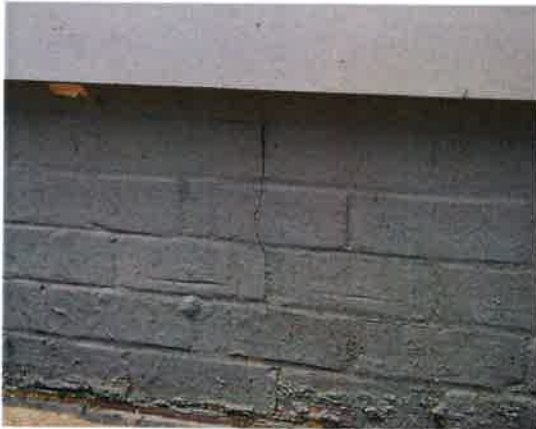
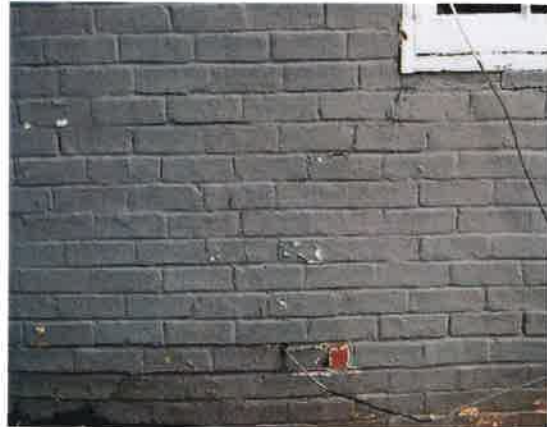
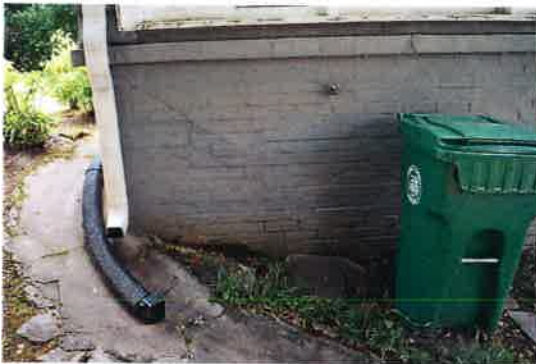
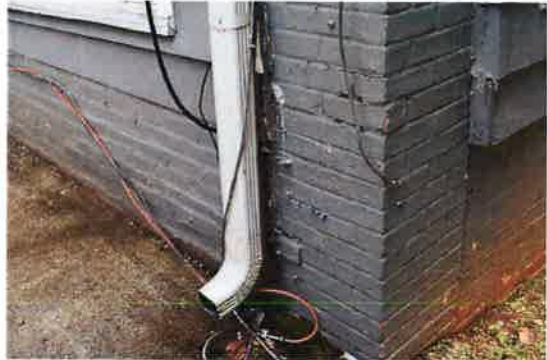
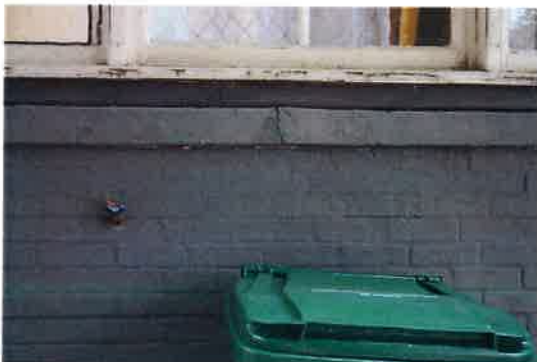
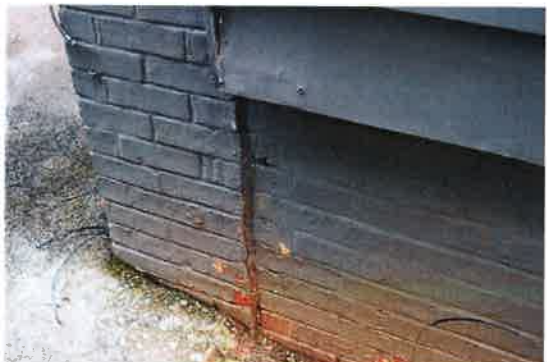
Existing brick cavity stem walls throughout show multiple attempts to point, patch and stabilize settling damage. Attempts as late as 3 years ago are already showing signs of failure.

Extensive cracking in the poured concrete floor of the crawlspace show further settling and soil instability below due to the 15%+ grade and long-term drainage issues.

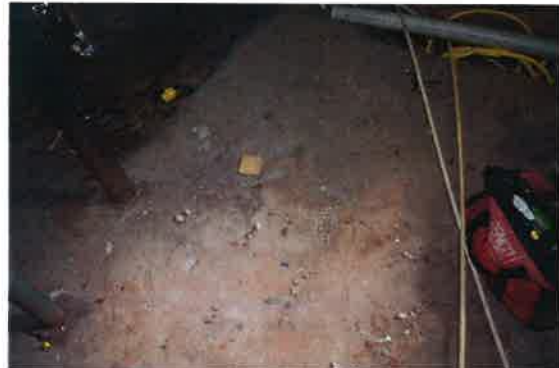
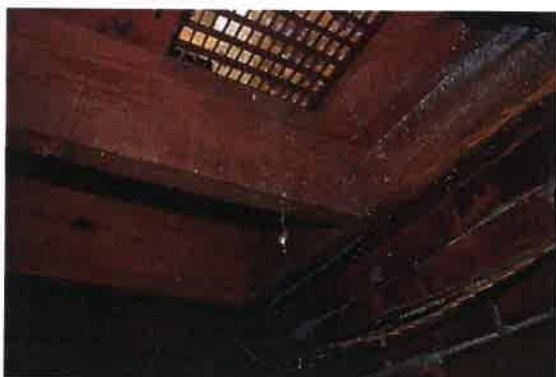
2x8 Floor joists are over spanned 36" average. Sagging entry level floors have been supported via multiple screw jacks in the Crawl/basement. However, 2nd floor joists would require removal of all ceilings, electrical and plumbing to facilitate 'sistering' of all joists.

In an effort to preserve and reinforce the existing structure, the owners had multiple screw jacks installed in addition to CMU walls to counteract the failure of the existing foundation system.

The photo to the right indicates persistent water intrusion under the original cavity stem walls and thru. the new CMU retaining wall

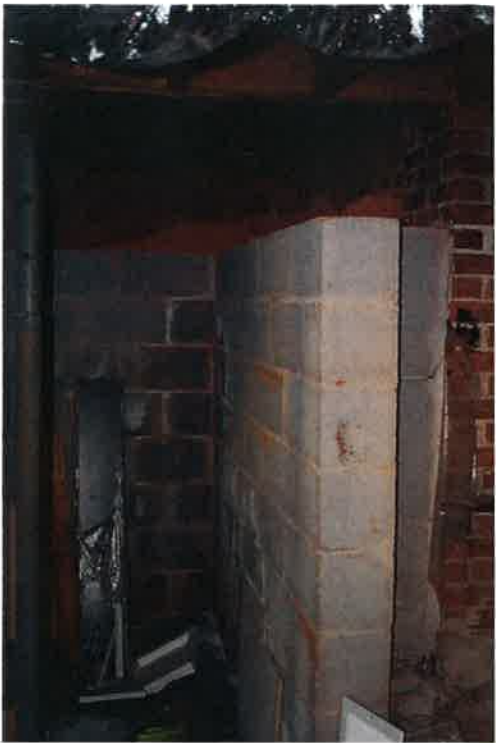
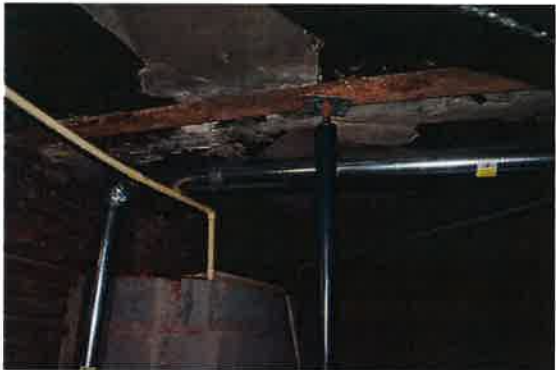
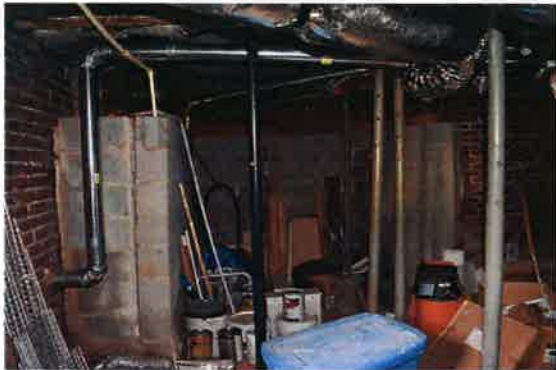
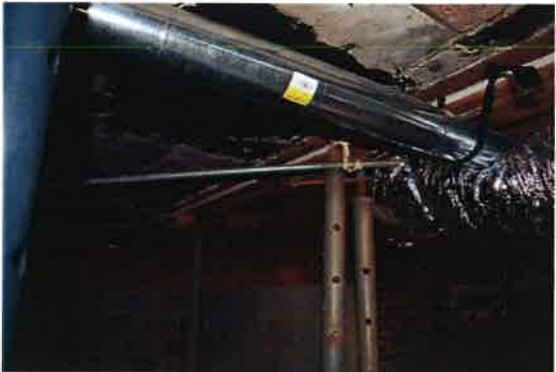
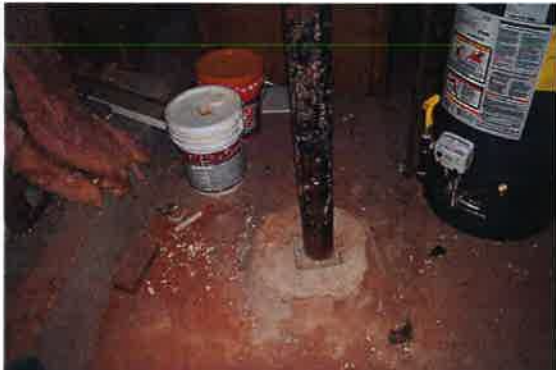
Retrofit steel bracing is supporting over-spanned floor joists, inadequate beams, and a suspended concrete slab. This level is rendered effectively unusable although the bracing employed is still insufficient.

The CMU wall installed three years ago is already showing signs of failure (leaning) and continued water intrusion.

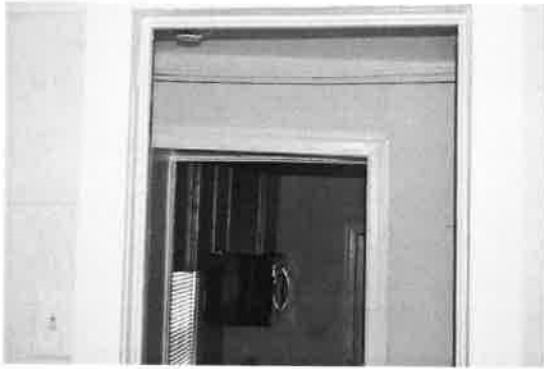
The pillars are showing cracking and signs of settling and unsupported movement.

Terrace level Ceilings are showing deflection from the over spanned floor joists above

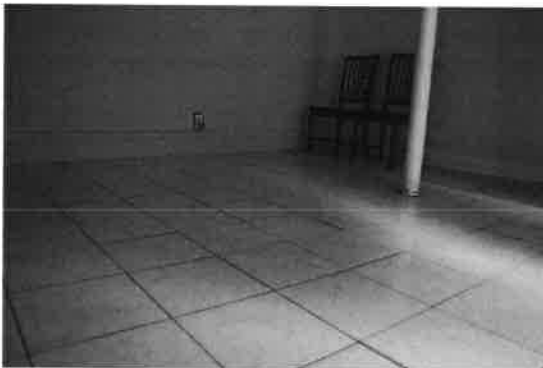
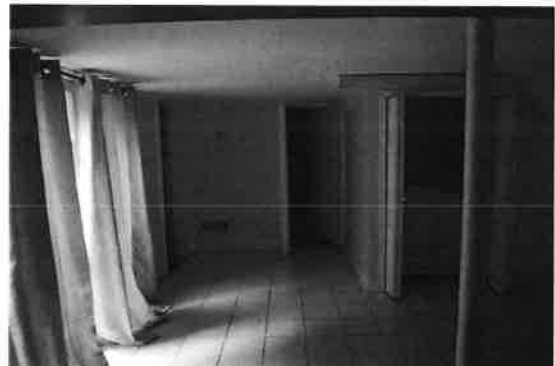
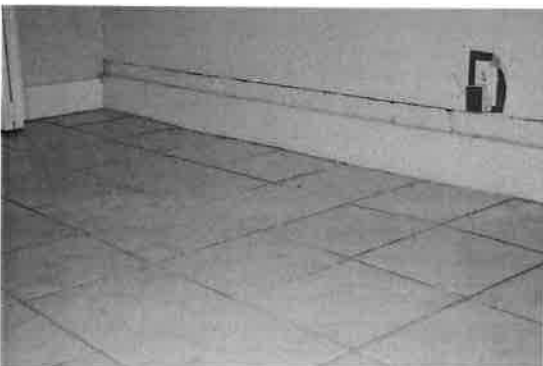
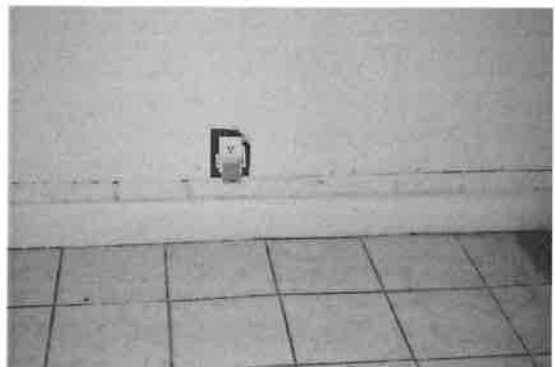
Within the scope of supporting the structure, the homeowners also performed cosmetic repairs throughout the interior of the home. Within 3 years the entry level walls show cracking in the drywall/plaster in numerous areas of the ceiling and wall surfaces, illustrating further movement of the structure post-repair.

In addition to cracking of drywall/plaster, extensive damage can be seen in the tile flooring of the kitchen, and separation within the hardwood flooring due to structure movement .

Uneven floor joists can be seen and felt throughout the entry level.

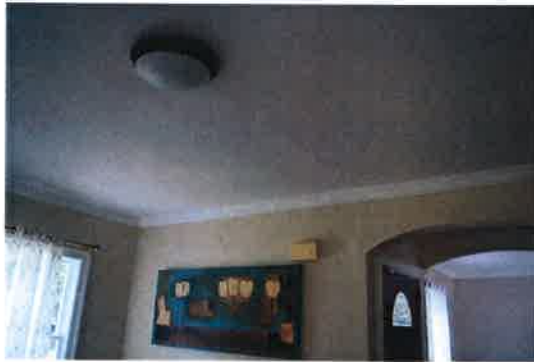
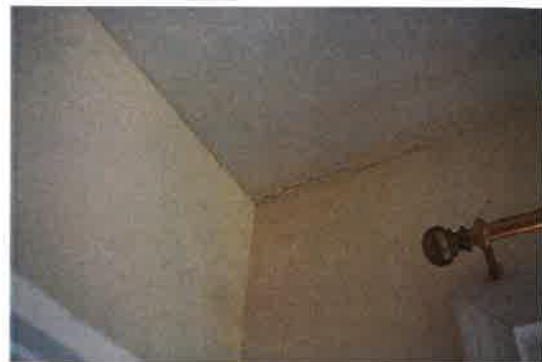
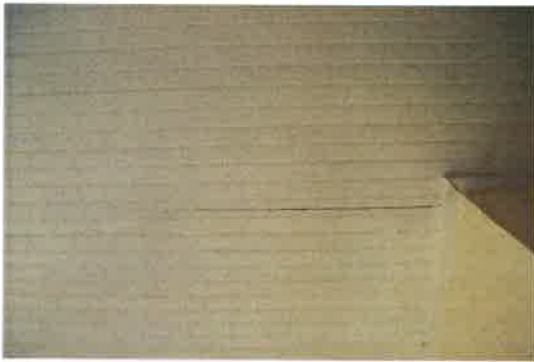
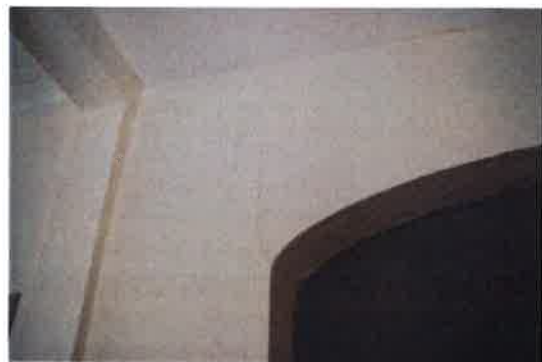
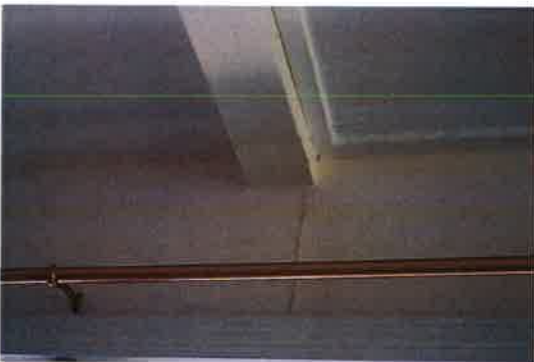
Walls on the upper-level present cracks over doorways, windows, and throughout walls in every room. Baseboard trim illustrates the movement of the floor joists below via gapping. Bathroom floor tiles have separated, unable to withstand the fluctuation of the over spanned floor joists below. Patching measures can be seen throughout that have already separated significantly in 3 years alone.
