Limited Asbestos Survey

631 Duram Park Road

Maxis Project No. 1-24-159A

Reference: **Limited Asbestos Survey**
Commercial Property
631 Duram Park Road
Decatur, Dekalb Co., Georgia
Project No.: 1-24-159A

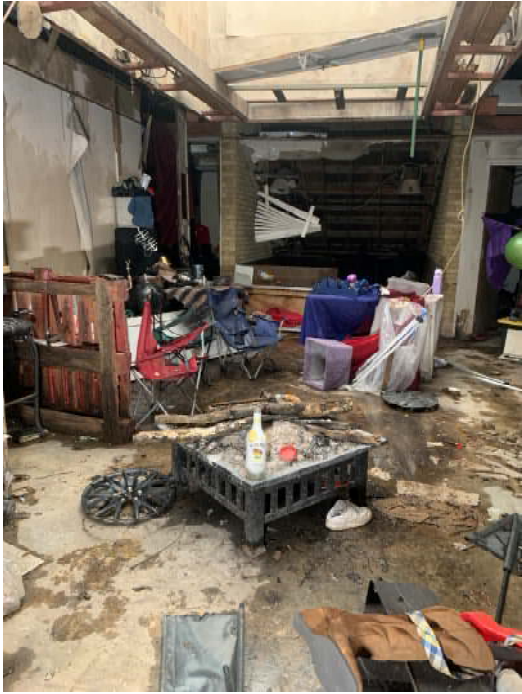
Based on the laboratory analytical results, seven (7) of the twenty-six (26) bulk samples tested positive for ACMs and are associated with joint compound and tape in the Skylight area (MM-3 and MM-4) and Room #6 (MM-11 and MM-12), and yellow baseboard molding tile in Bathroom #1/#2 (MM-15 and MM-16) and Bathroom #3 (MM-21). NESHAP 40 CFR 61 Part M defines positive ACMs as any material which contain >1% asbestos content. Additionally, samples for which asbestos is detected at <1% are reported as trace, “<1%”. “None Detected” indicates that no asbestos fibers were observed via the PLM laboratory process. Positive results are summarized below:

Skylight Area (MM-3 and MM-4)

It is our understanding that the commercial structure is slated for demolition at this time. Due to likelihood of disturbance during demolition/renovation that may occur, the material must be abated prior to any demolition/renovation activities, or the entire demolished structure should be managed as ACMs and transported to an appropriate landfill per the Georgia Solid Waste Rules (391-3-4 (8) (a) (b)). The identified ACM must be removed by a Georgia certified asbestos abatement contractor prior to renovation or demolition. A

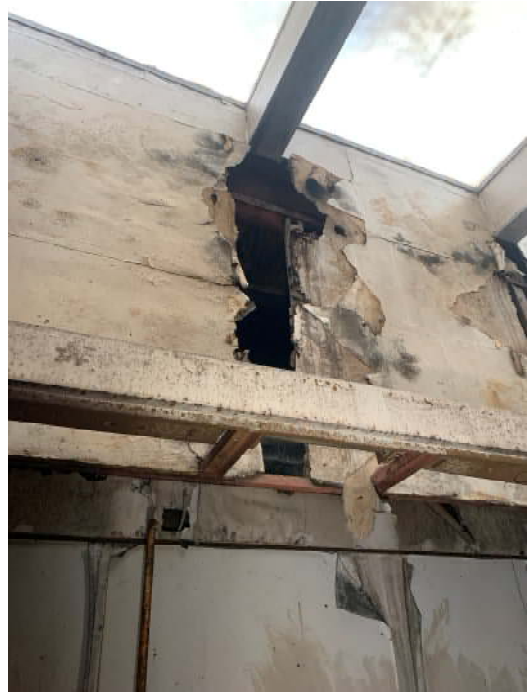
Skylight Area (MM-3 and MM-4)

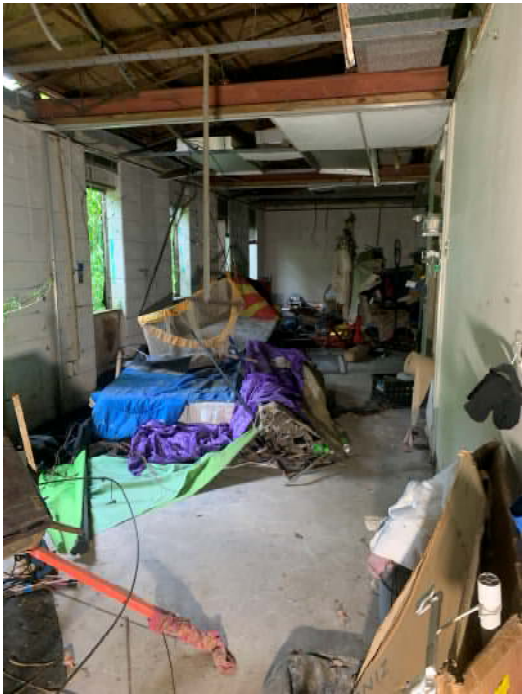
Room #6 (MM-11 and MM-12)

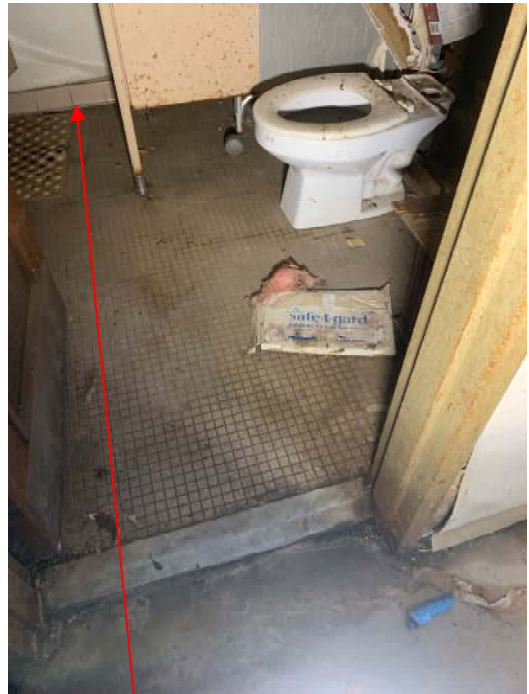
Yellow baseboard molding tile appears to be the same in all three bathrooms.

Bathroom #3 (MM-21), same tile present in Bathroom #1 and Bathroom #2
