PROPOSED CHANGE ORDER REQUEST

Contract Name: Design/Build Roof Replacement & Painting of Steel Ground Storage Tanks at Scott Candler Water Treatment Plant **Date:** 6/1/2020
Contractor: Reeves Young LLC
Contract Number: 1073854 **Contract Amendment Number:** 2
Contract Amendment Category: Cost Schedule Scope Deliverables

Field Report for Site Visit April 1, 2020

Project:	Water Tanks Repairs in Scott Candler Water Filtration Plant (SCWFP)	www.woodplc.com
Location:	Water Tank # 1, SCWFP, 4830 Winters Chapel Rd, Doraville, 30360	
Client:	DeKalb County Department of Watershed Management	
Contractor:	Reeves Young	
Date On-Site:	April 1, 2020	
Purpose of Visit:	Inspect condition of Tank # 1 roof framing members	
Report Date:	April 2, 2020	
Representatives On-Site:	J. Michael Garver P.E.	
Report Reviewed By:	Mirsada Ilic, P.E.

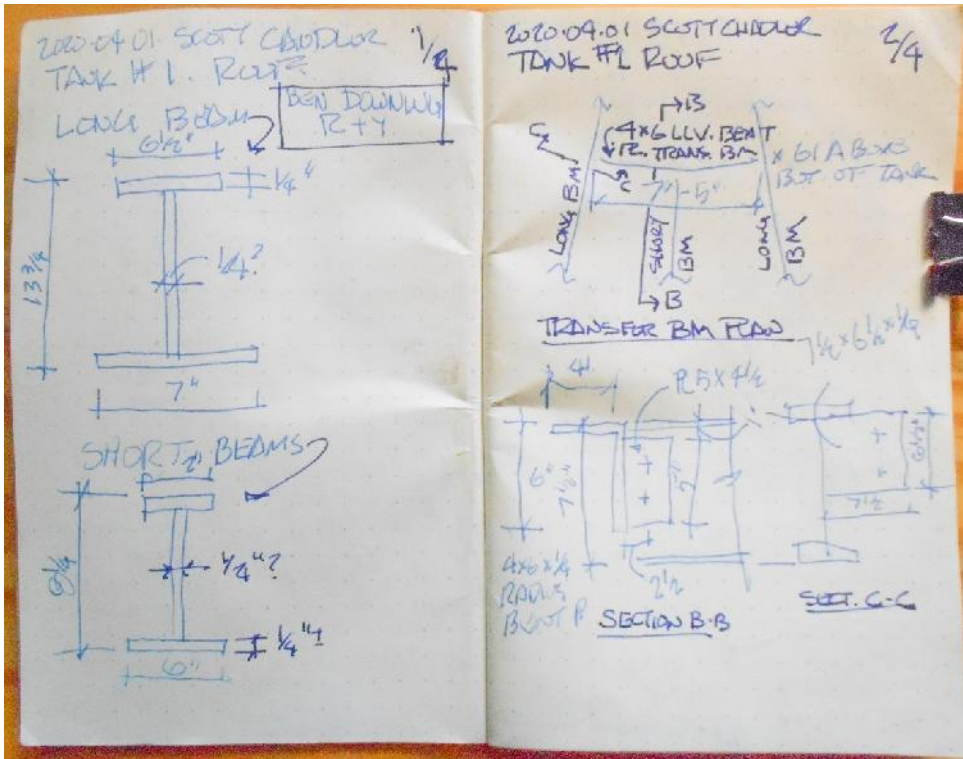
Photograph No. 19:

-) Long beams are built-up plate beams approximately 13 ¾” deep with a ¼” x 6 ½” top flange and ¼” x 7” bottom flange. **(Refer to Photographs 19 and 20)**
-) Short beams are built-up plate beams approximately 8 ¼” deep with a ¼” x 1” to 2” top flange and ¼” x 6” bottom flange. **(Refer to Photographs 19 and 20)**
-) The tank roof deck appears to be made of steel plate with an unknown thickness.

Pages 1 and 2 of field notes.

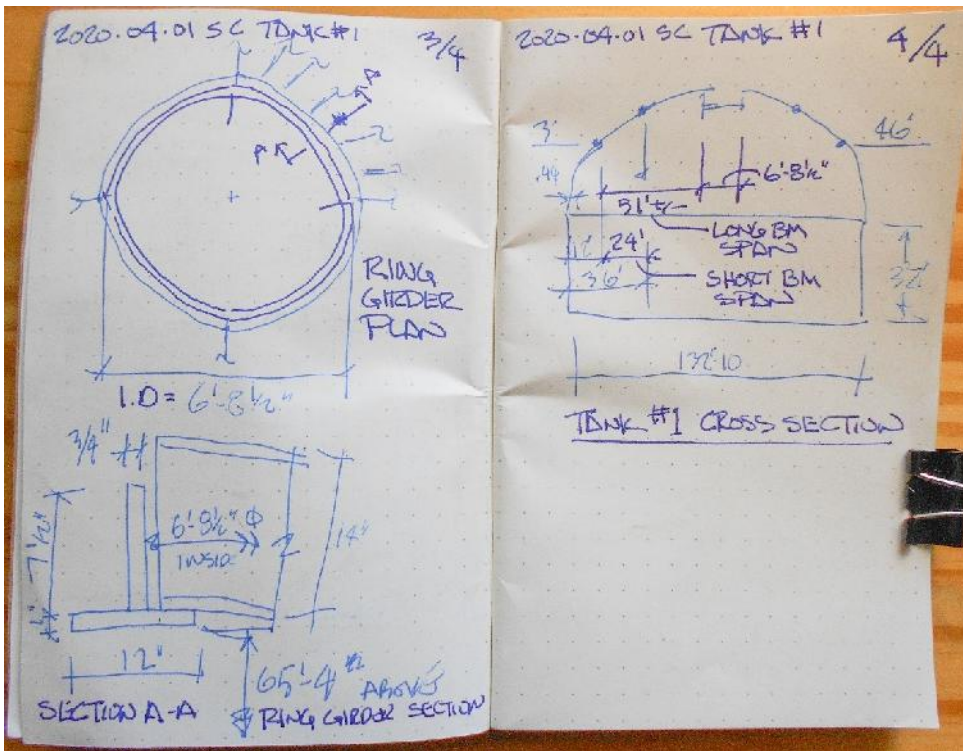
Photograph No. 20:

Pages 3 and 4 of field notes.
