District 4 Senior Center Feasibility Study

4875 Elam Road
Stone Mountain, GA 30083
Parcel ID# 15 256 01 007

Date: July 14, 2017

Prepared by: Amec Foster Wheeler Environment & Infrastructure, Inc.
1075 Big Shanty Road, Suite 100
Kennesaw, Georgia 30144

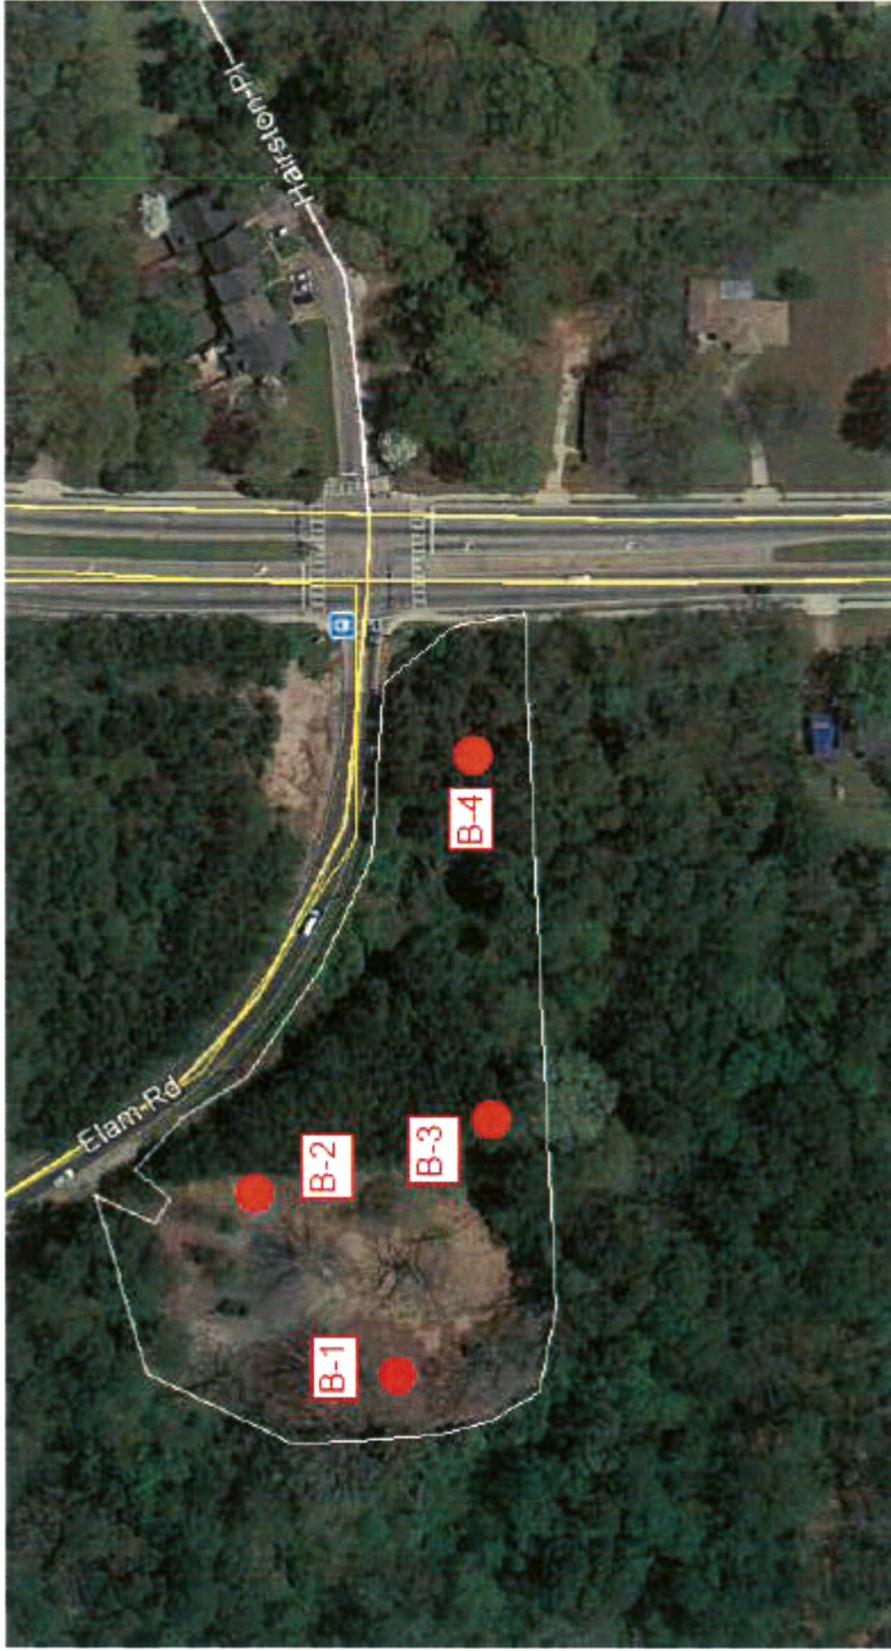
● Approximate Boring Location

In order to explore the subsurface conditions in the possible areas of construction, a total of four soil test borings were performed at the approximate locations shown on the attached boring location plan. The borings were drilled to approximate termination depths of 15 to 30 feet below existing site grades. Borings were laid out in likely areas of development based on input from the client.

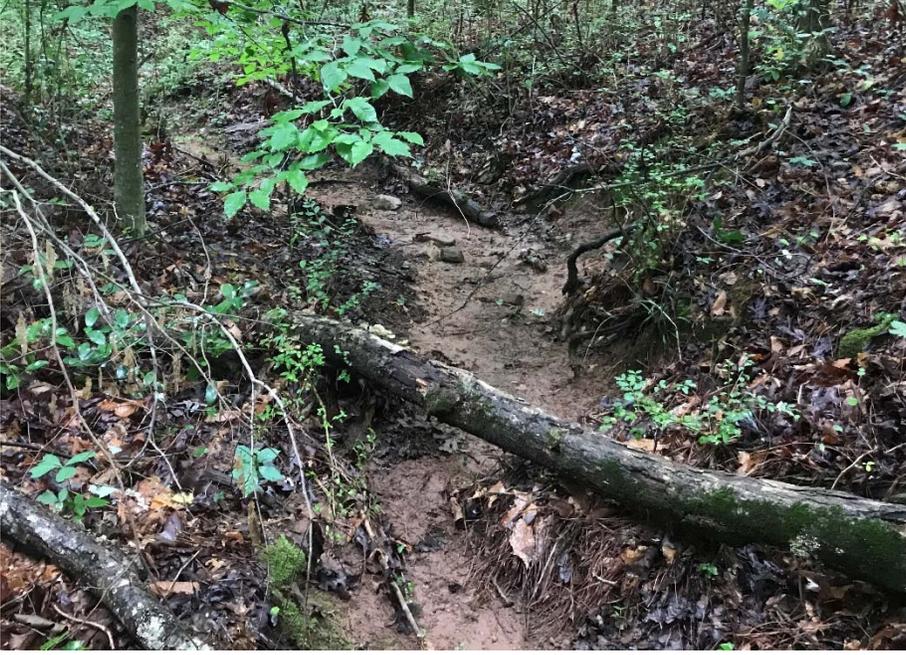
A photograph showing a dirt path or stream bed in a wooded area. A large, moss-covered log lies across the path. The ground is covered with fallen leaves and some green plants are growing along the path.	<p>Client: DeKalb County</p> <p>Location: Elam Road</p> <p>Project No.: 6166170527</p> <p>Date: 06.16.17</p> <p>Photo No.: 1</p> <p>Photographer: KPH</p> <p>Description: View upstream of Stream 1, facing northeast.</p>

No wetlands were observed; however, an ephemeral stream (Ephemeral Stream 1) was delineated along the southern property boundary collocated with the swale observed on the topographic map, which flows southwest toward the lake at Hairston Park. Photographs are provided in Appendix 3.

Ephemeral Stream 1 is an unnamed ephemeral tributary to Barbashela Creek, which flows into Snapfinger Creek and subsequently into the South River. The channel is approximately 2 to 3 feet (ft) wide and 0.5 to 1 ft deep, with a substrate dominated by clay and smaller components of sand, silt, and pebbles. Flow was absent during the field survey, but standing pools 0.1 to 1.5 ft in depth were noted below headcuts.

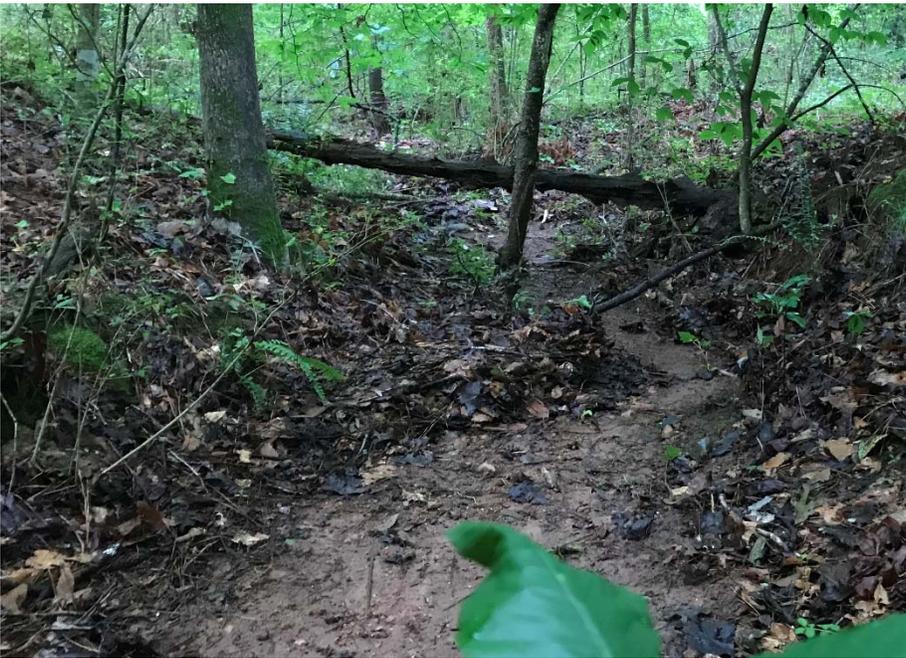
A photograph showing a dirt path or stream bed in a wooded area, viewed from a different angle than the first photo. A large, moss-covered log lies across the path. The ground is covered with fallen leaves and some green plants are growing along the path.	<p>Client: DeKalb County</p> <p>Location: Elam Road</p> <p>Project No.: 6166170527</p> <p>Date: 06.16.17</p> <p>Photo No.: 2</p> <p>Photographer: KPH</p> <p>Description: View downstream of Stream 1, facing southwest.</p>
